# **PortCarlisle, Hadrian's Wall, August 2021: curtain Wall consolidation and gate relocation**

## **Hadrian's Wall Community Archaeology Project (WallCAP)**

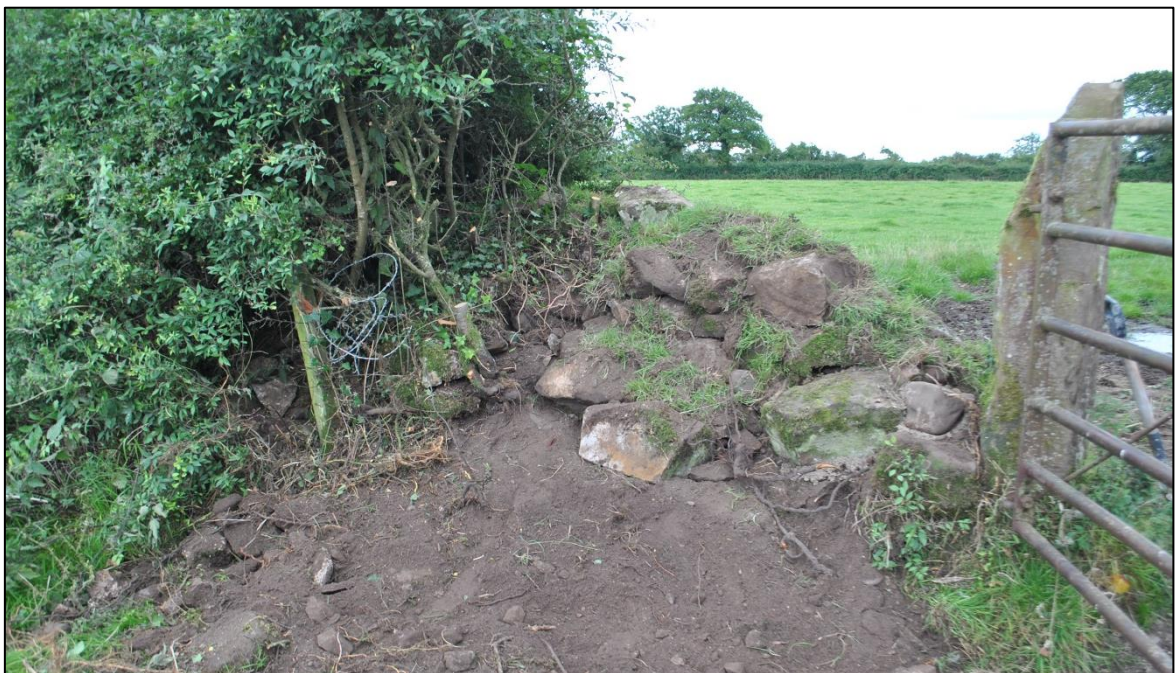
**Fig. 1:** east of the old gate showing the north 'face' after removal of the hedge (as to left) and initial tidying and turf capping. All the core material was loose and had been re-piled in the past. South-east facing photo

The preparation work for consolidation fully revealed the poor state of the Wall in this location, especially to the east of the gate (fig. 1). On the west side up to three courses of the south face survived *in-situ* but the north side had completely collapsed with no facing stone remaining and little *in-situ* core. The situation was worse on the east side with only up to two courses of the south face still *in-situ* and the north 'face' under the vegetation consisting only of piled up, loose core stones. This discrepancy in survival of

the faces has been caused by the repeated flooding of the lower, northern field, with the shifting of light estuarine soils during inundations repeatedly undermining the curtain Wall remains. Once stripped of facing stone the destabilised core collapsed towards the north. Continuing attempts by those farming the land to improve drainage in the fields has also repeatedly disturbed the archaeology. Drains run alongside and through the Wall line. The destabilising of the Wall from the north was noted in excavation and was only too apparent during the consolidation work. Loose core stones scattered around the Wall remains were stacked up on the northern slope of what had been the core on each side of the gate to further protect the *in-situ* and re-bedded southern facing stones (fig. 2).

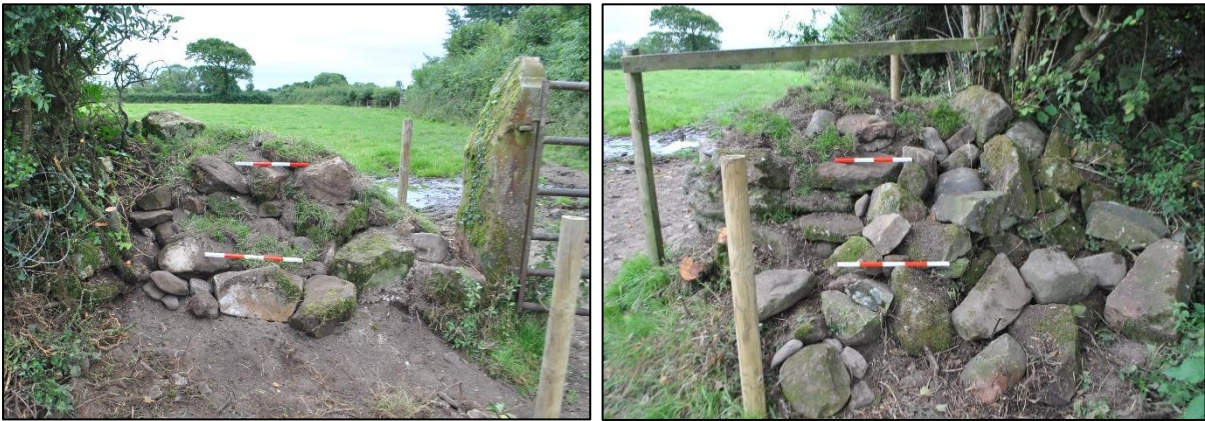
**Fig. 2: re-piled loose core stones protecting the *in-situ* southern facing stones. Left: east of the gate; right: west of the gate. Looking south-west**

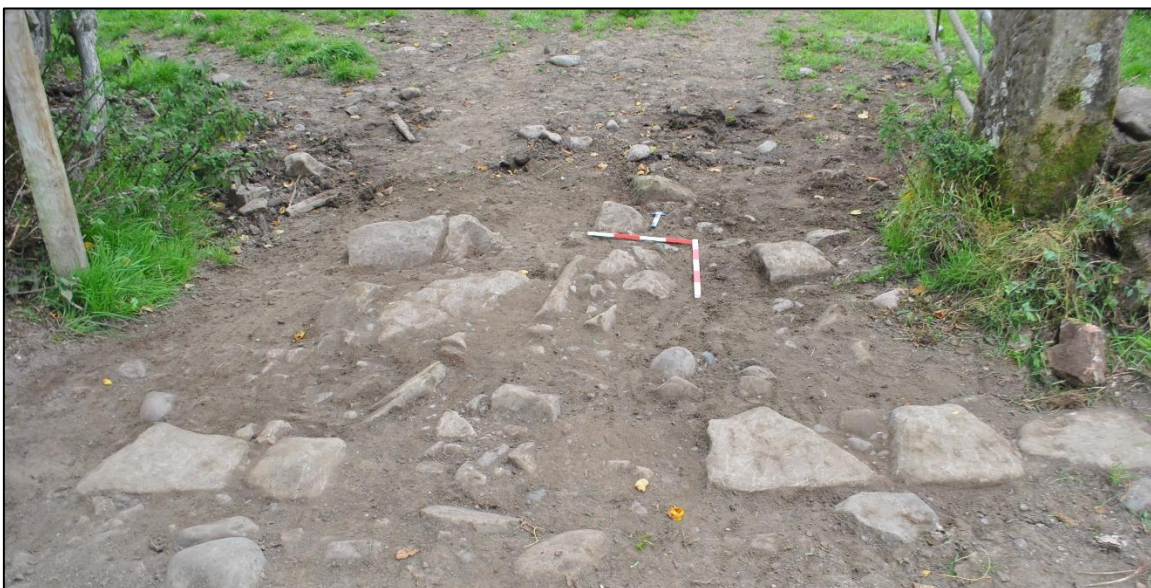
The intention had been to excavate a narrow north-south section through the gateway against apparently *in-situ* facing stones, to look for Turf Wall remnants and confirm the level of the foundation course. However, after a summer of heavy rains and further wear, the line and width of the north-south field drain punched through the gateway was much clearer, as was the extent of the disturbance caused by its insertion (fig 3). The putative northern line of facing stones also appeared more likely to be undermined, slipped and rotated stones. Despite earlier weeks of rain having washed more sediment from above and around the stones bedded in the gap, the ground was also extremely hard, and it was decided that attempting any excavation would cause more damage than was warranted by the likely outcome.

**Fig. 3: stones in the gateway. Facing stones in the foreground are *in-situ*. Looking north**

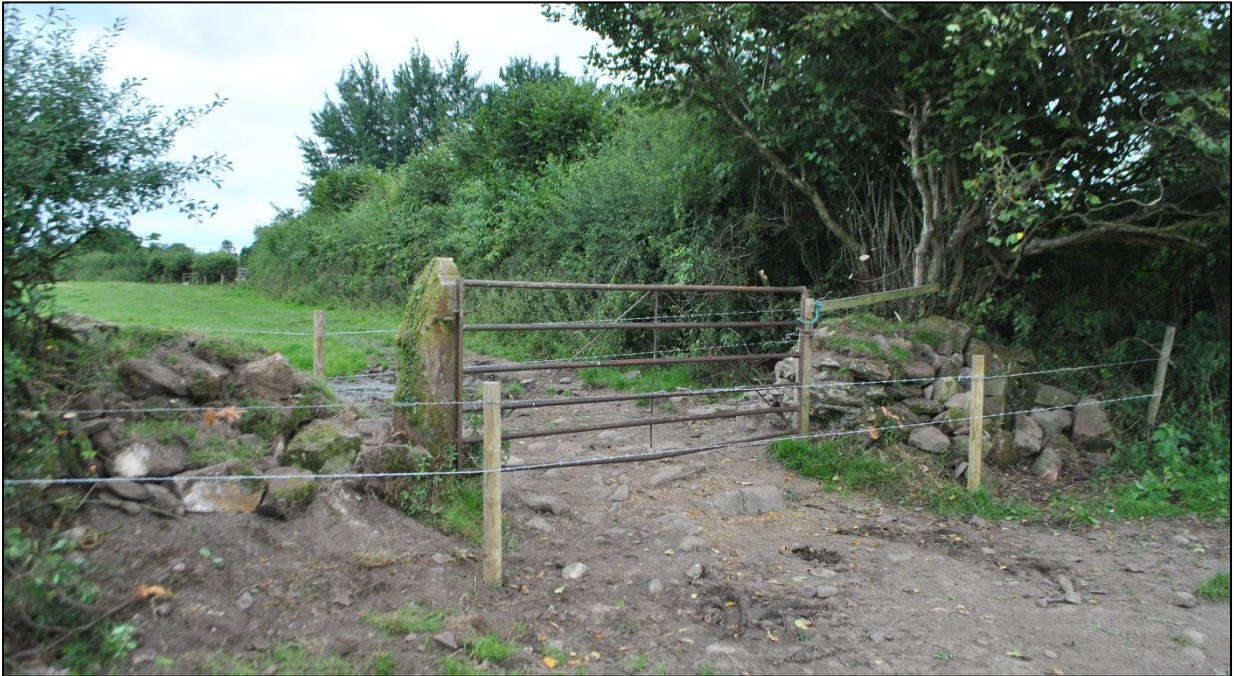
**Fig. 4: the wired-shut and fenced gateway with the surviving curtain Wall. Photo looking south-west.**

The old gate was wired shut across the gap, new wooden fencing posts erected one metre north and south of the Wall remains and the whole area fenced off with a double strand of barbed wire (fig. 4). No further damage can now be inflicted by stock and machinery on the consolidated curtain Wall remnants or on any surviving archaeology in the gateway.

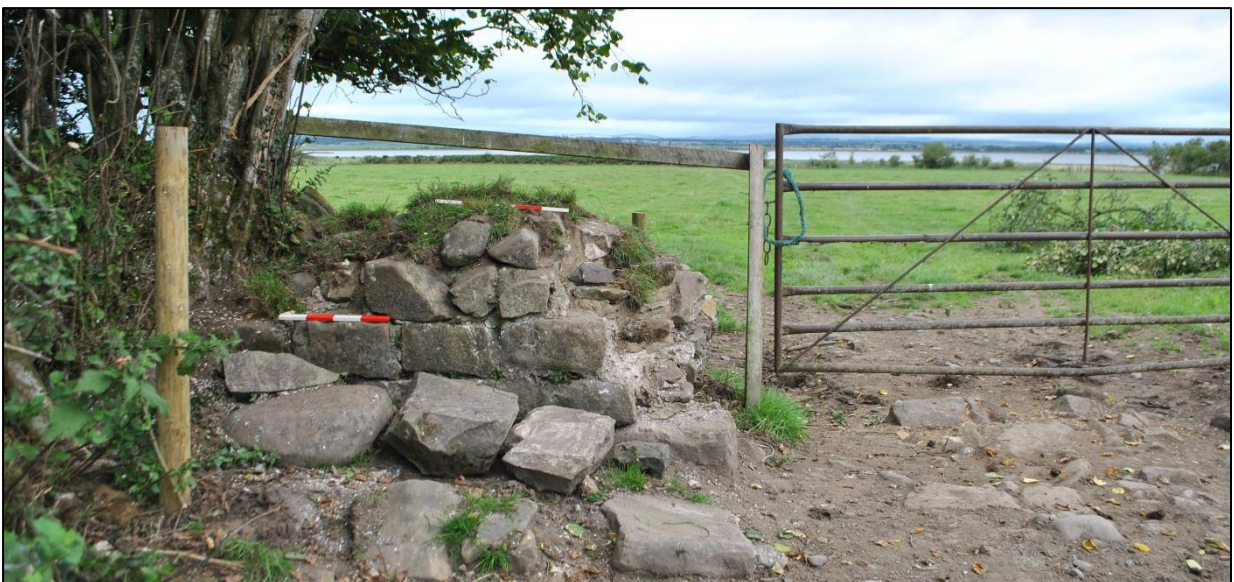
**Fig. 5: consolidated Wall west of the gateway before the final re-fencing. Photo looking north-north-east.**

- *Consolidated section of Wall west of gateway*: 1.95m east-west by 1.35m wide (2.1m wide including tumble re-piled to protect south face); max. 1.05m high (fig. 5).
- Maximum width in gateway between line of *in-situ* south facing stones/foundation stones and line of northern facing stones (probably displaced): 1.75m (fig. 3).

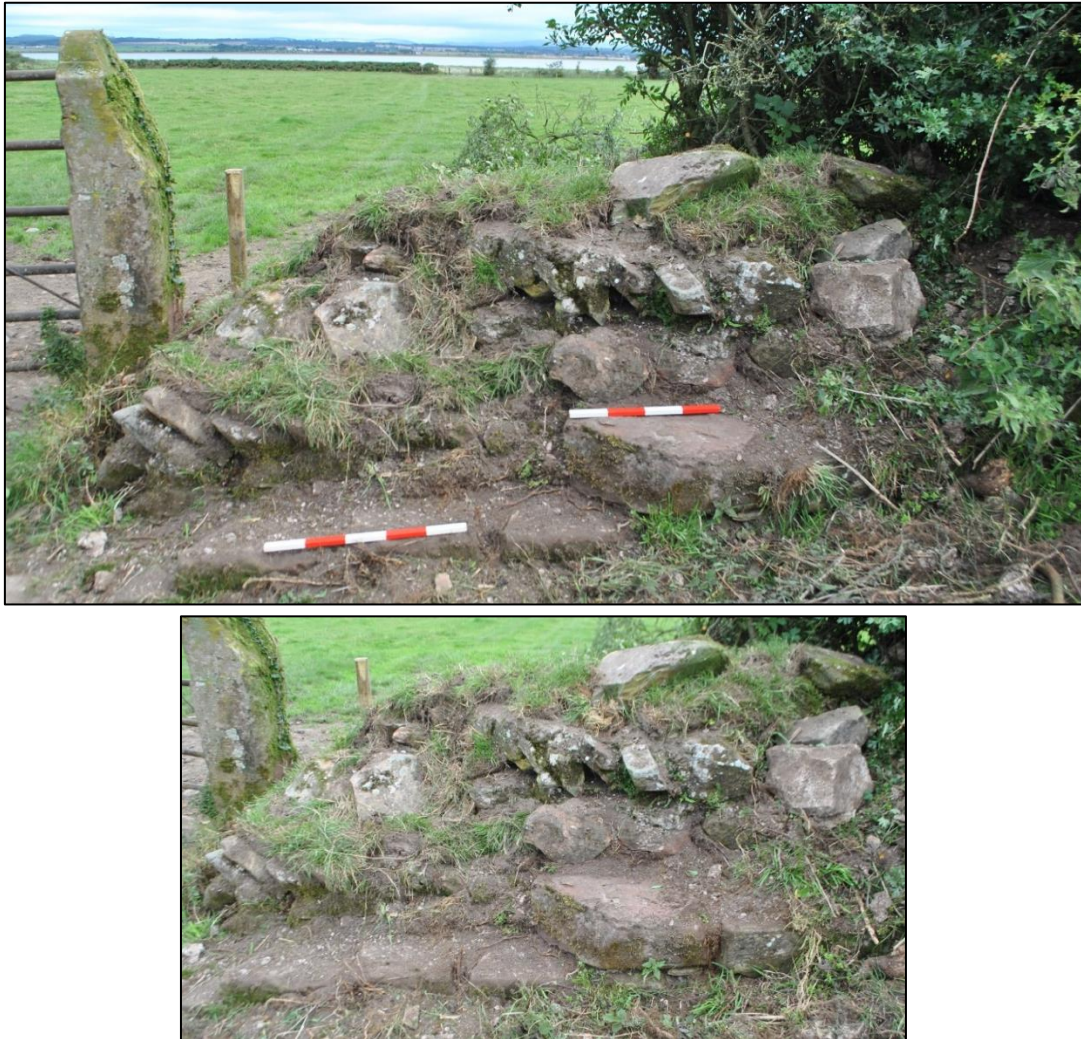
- *Consolidated section of Wall east of gateway*: 2.1m east-west by 1.65m wide; max. 1.1m high (fig. 4). The field dyke is up to 3.5m wide.
- *Measurements of south-facing stones revealed to east of gateway*  
 Foundation course, moving west to east: 0.38m long x 0.26m wide (as seen); 0.32m long by 0.23m wide (as seen); 0.32m long by 0.21m wide (as seen) (figs 4 and 6);  
 Next course up, *in-situ* stones from west: 0.52m long by 0.31m wide (as seen) by 0.18m high (chock stones?); 0.21m long by 0.25m wide (as seen) by 0.17m high (fig. 6).

**Fig. 6:** East of the gate: *in-situ* facing stones. Lower photo shows partial upper course. Photos looking north

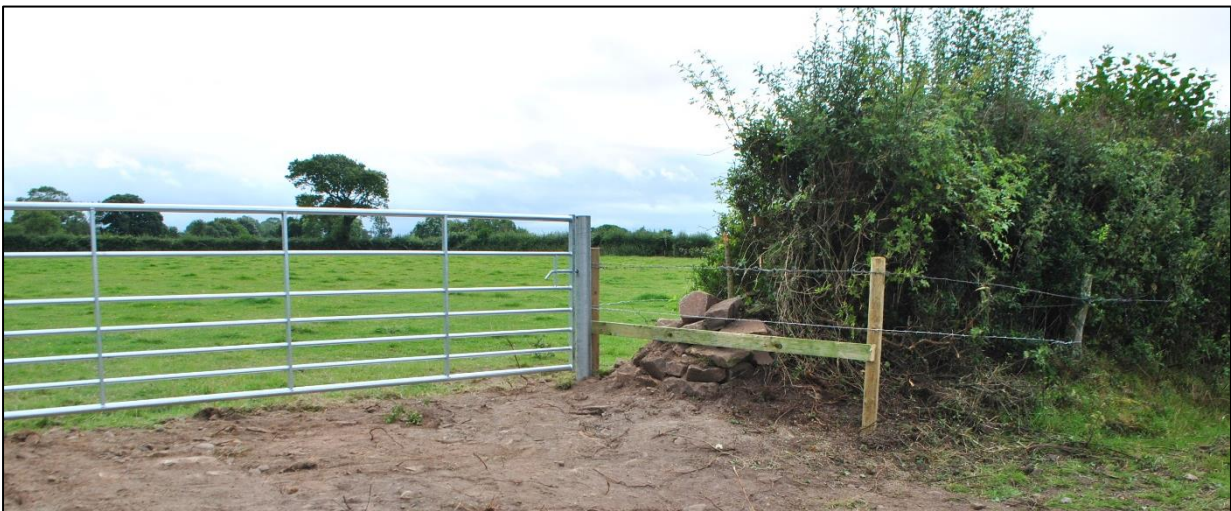
looking mortar sealed an uneven layer of core stones below. An area of c. 0.6m<sup>2</sup> of the mortar was uncovered. The *Heritage Consolidation* team compared this mortar to that used, possibly in the 1970s, roughly to repair the Wall stub to the west of the old gate, and colour and composition appeared to match.

**Fig. 7: the new gate with a cairn constructed over the consolidated possible *in-situ* core. Looking south-east**

There was no need to remove the mortar patch or to disturb any possibly *in-situ* core stones below to erect the gate. Instead the rubble end of field bank above, comprising re-used Wall core, was consolidated by *Heritage Consolidation* with lime mortar and an extra skim of lime mortar laid over the existing ground-level modern mortar. The modern mortar work may have been intended to create a firmer surface just west of the agricultural building or as foundations for a wall running from the dyke up to the west wall of the structure. Finally, the contractors used core stones from the demolished dyke to build a dry-stone cairn over the area (fig. 7). Any possible *in-situ* archaeology is now secure behind a barbed wire fence and beneath the dry-stone structure and mortar layers.
