PortCarlisle, Hadrian's Wall, April 2021: PC21, excavations across the Wall

Hadrian's Wall Community Archaeology Project (WallCAP)

Jane Harrison and Kathryn Murphy

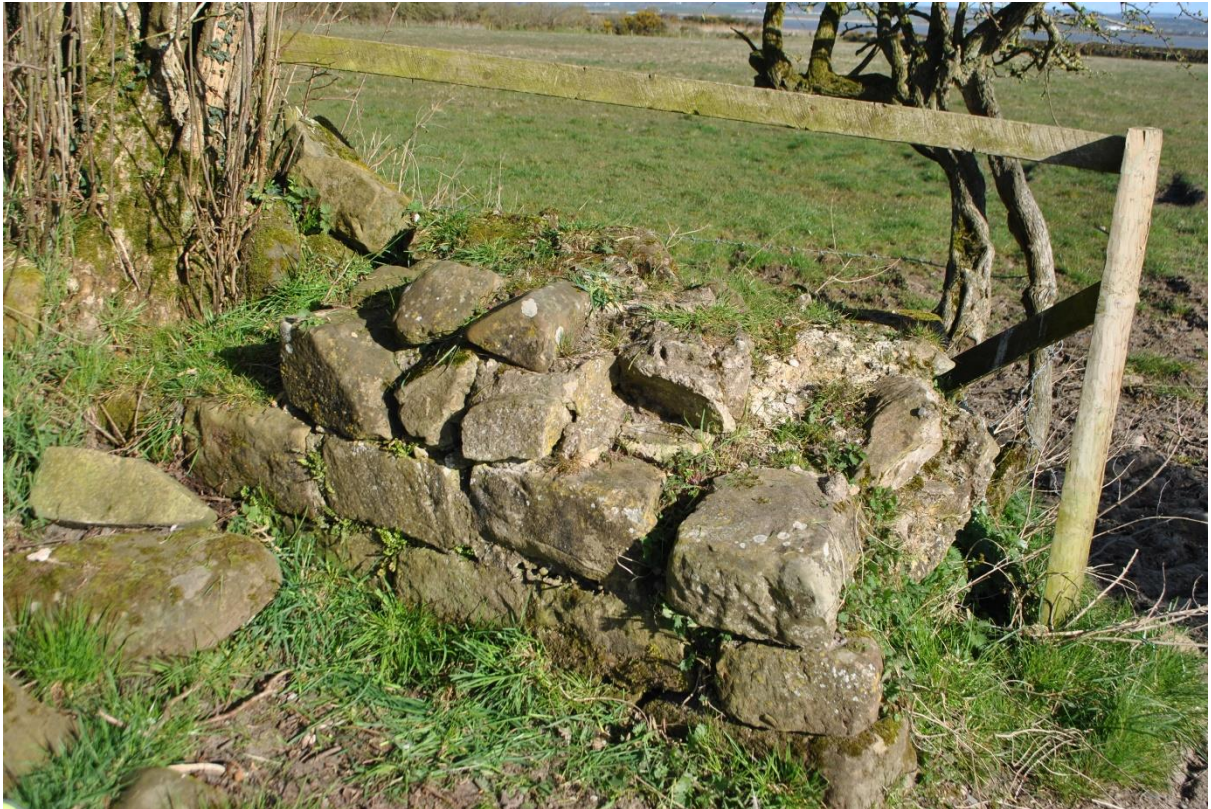
Surviving courses of the Wall west of the existing field gateway, looking north-west: April 2021

The opening for the gate is too narrow for modern farm machinery and the eastern end of the Wall courses has clearly been hit by traffic through the gate and are in urgent need of consolidation work. The current gate is at the western end of the boundary of the field to the south, and Trench 1 was located to investigate whether the gate could be moved to the east, where the north-south boundary of the northern field meets the wall line. This site was suggested as historic mapping records a now demolished agricultural building in that corner (fig. 8). Moving the gate would allow the preservation of the upstanding remains, allow a wider access point for machinery further east, and provide an opportunity to investigate the history of the curtain in this length of the Wall. Trench 2 was placed to investigate further the condition of the buried Wall in this area.

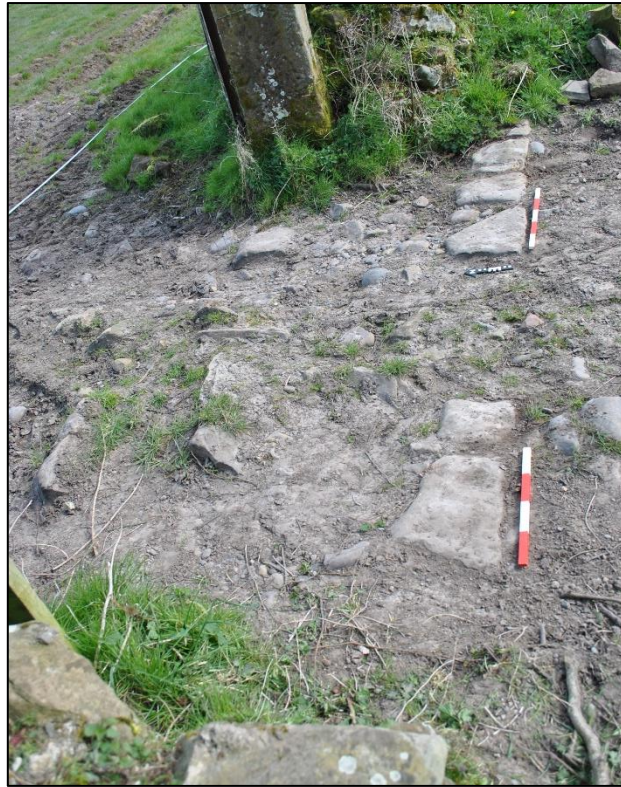
The upper surfaces of at least six faced curtain stones – likely foundation stones by comparison with the standing remains – were visible flush with the ground in the opening of the present gateway (figs 5a and 5b). A field drain running north-south cuts between those stones in the middle of the opening, and a section of surviving stone Wall foundations and any possible turf Wall remains could easily be obtained by digging a slot over the breach made by the drain. The standing curtain remains east of the gate, visible two years ago, were well hidden by April 2021 beneath regrowth of vegetation. This will need to be cleared and suppressed when the consolidation and refencing works are completed.

Fig. 5a: gateway with facing stones looking just north of east

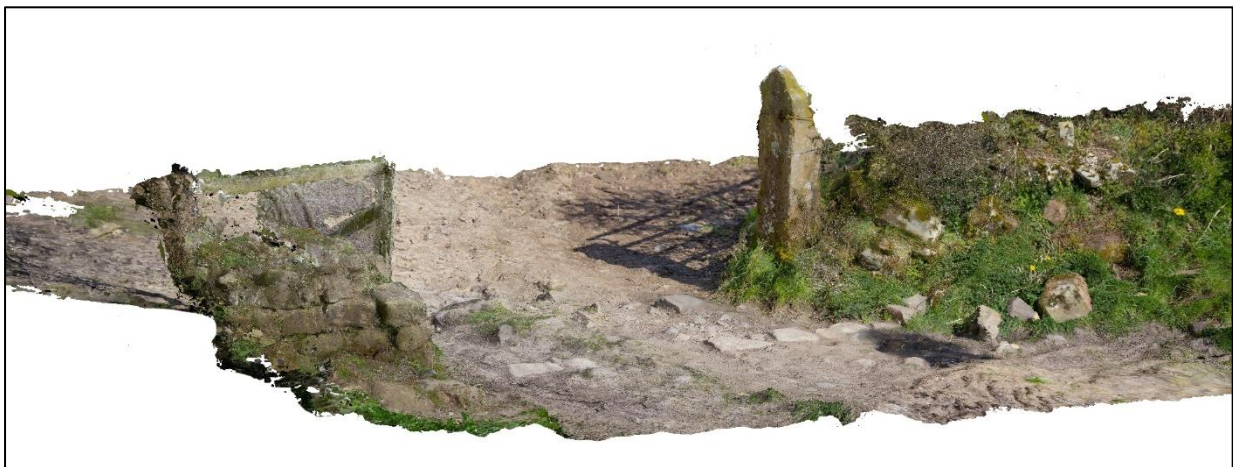
Fig. 5b: photogrammetry of the gateway looking NNE

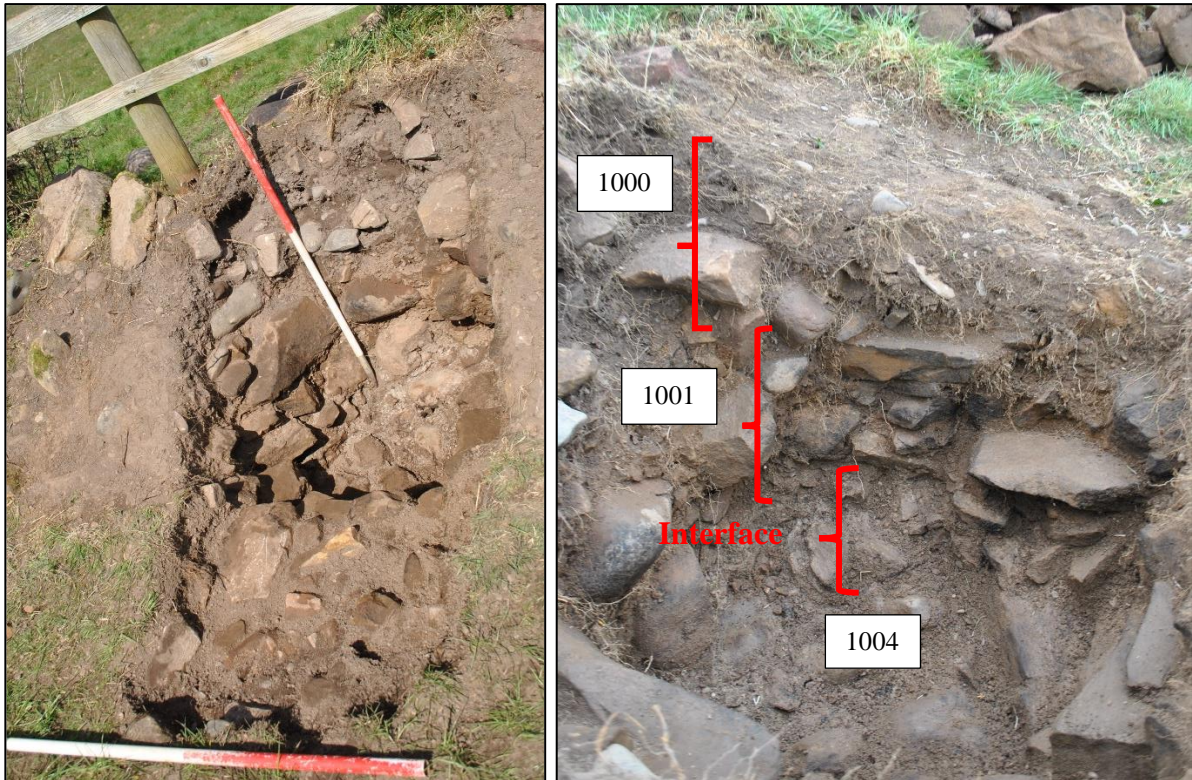
Natural geology was reached in the southern half of the trench at c 7.82mOD (1004). Sandstone bedrock stained with mineral deposits was encountered in the south of this part of the trench. This may have been part of a relict natural 'sea bank'. Otherwise the natural drift geology was a mixed and reworked sandy clay of glacial till and fluvial deposits, with some cobbles and stone shatter. There were more stones, shatter and grit at the interface between the till and the layer above, (1001). None of the boundaries were clear in this area, with extended interfaces between layers. Layer (1001) was nearly 0.4m deep in the middle of the hedge bank and found across Trench 1. There were fewer stones overall in the lowest 0.25m of interface with (1004) below, with sub-rounded cobbles similar to those in the glacial till predominating over larger sub-angular shatter. In the upper part of layer (1001) yellow sandstone rubble made up c. 80% of the context, with most being sub-angular cobbles but with a considerable number of larger sub-angular stones up to 0.2-0.4m. This latter stone was more likely to have made up the substance of curtain core material and contrasted with the large, rounded beach cobbles of red sandstone readily available on the shore of the Solway Firth just to the north. The lowest level of this compact stony layer (1001) lay just below ground level of the southern field.

Fig. 9: left, Trench 1, south. Left, looking NNW, right looking near east

Overall layer, (1001) could be characterised as stone, including likely wall core, compacted over time by water action washing out soil matrix and by the construction of an agricultural building in the area between the 1950s and 1970s. The stone may have been used in creating the hedge bank, with some spread from the bank for the building base before being piled back up again to reform the hedge bank.

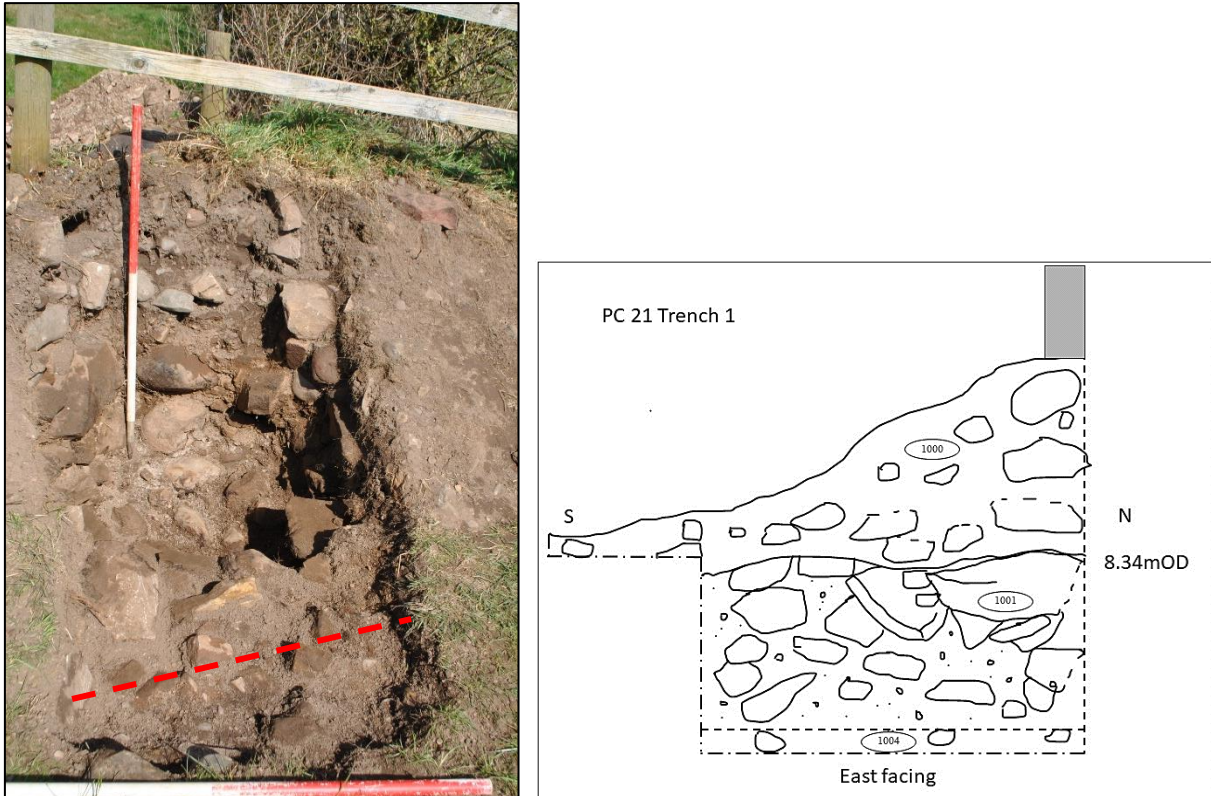
A small extension was dug 0.6m south from Trench 1 down to just below the level at which any surviving *in-situ* curtain foundation might be found. Sandy silt layer (1006) contained 50% sub-angular and sub-rounded cobbles of yellow and red sandstone, with the more sorted and smaller cobbles comprising the backfill of the rubble drain clearly visible. The extension clarified the line of the pre-outbuilding rubble field drain running west-east, but discovered no facing stones or foundations.

Fig. 10: left, Trench 1 after excavation, looking NNE, with northern side of rubble drain indicated in red
Fig 11: right, Trench 1 after excavation E facing section, 1.8m long

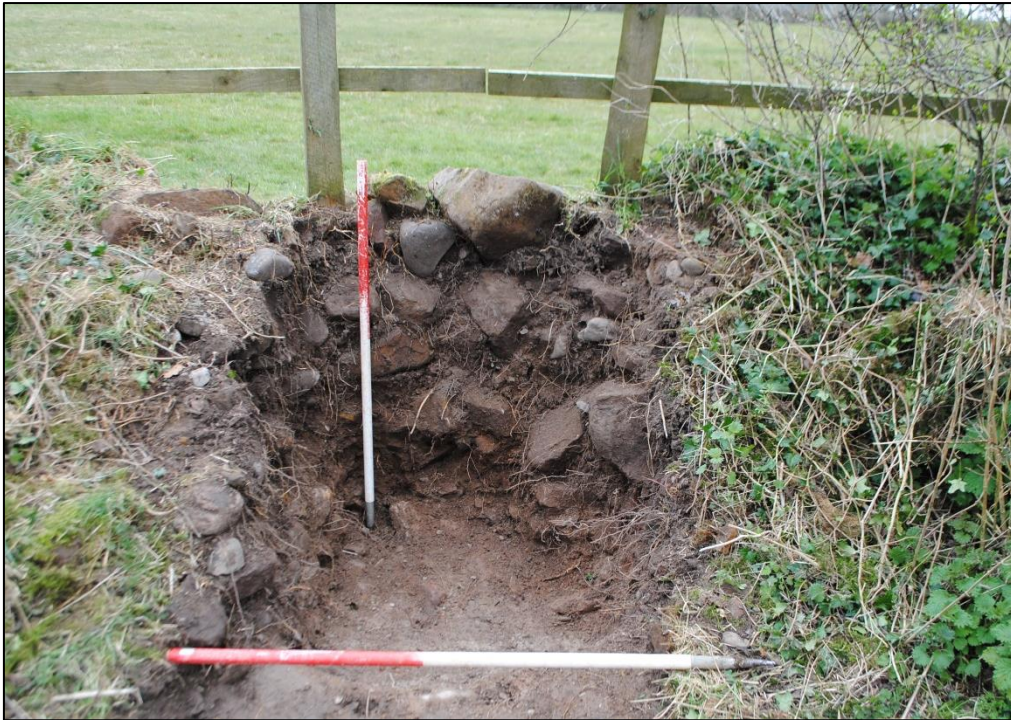
Natural geology was also reached in Trench 1, north of the wooden fence. Excavation stopped at 8mOD, about 0.25m into the interface (1005) between the field bank layer above and the mixed natural glacial till and fluvial deposits below. There had been more reworking of this layer than to the south, caused by the flooding of the lower northern field and a rising and falling water table. In October 2020, the south-east corner of the field, adjacent to Trench 1 north, was under water; the northern field is about 0.2m lower than the one to the south. The boundary between this interface (1005) and the field bank (1003) above was clearer north of the fence, than to the south of fence. Sandy silt (1003) was equivalent to (1001) to the south, and was also up to 0.5m deep in the centre of the bank. However, (1003) contained far fewer stones than to the south, being only c 10% sub-rounded cobbles and occasional larger sub-angular shatter; (1003) and (1002) above also produced several very corroded Fe fragments, probably from agricultural equipment, and mostly found at the boundary between (1003) and the layer above. Layer (1003) thus comprised material piled up to recreate the field bank including silty flood deposits mixed with glacial till material, cobbles and some possible wall core. There was far more soil and fewer larger stones in (1003) than the equivalent deposit to the south, suggesting Trench 1 south may have been closer to the line of the curtain but also indicating the silt deposition resulting from flooding.

Layer (1002) comprised the upper makeup of northern half of the field bank with topsoil and vegetation. The gritty, sandy silt was up to 0.25m deep. The layer was c 15% stone: the larger sub-angular stones may have been re-purposed wall core, but most of the stone was smaller sub-rounded and sub-angular red and yellow sandstone cobbles and pebbles. The top of this layer rose from ground level in the north at c 8.25mOD to the wooden fence line at c 8.9mOD.

Fig. 12: Trench 1 north, after excavation, facing south

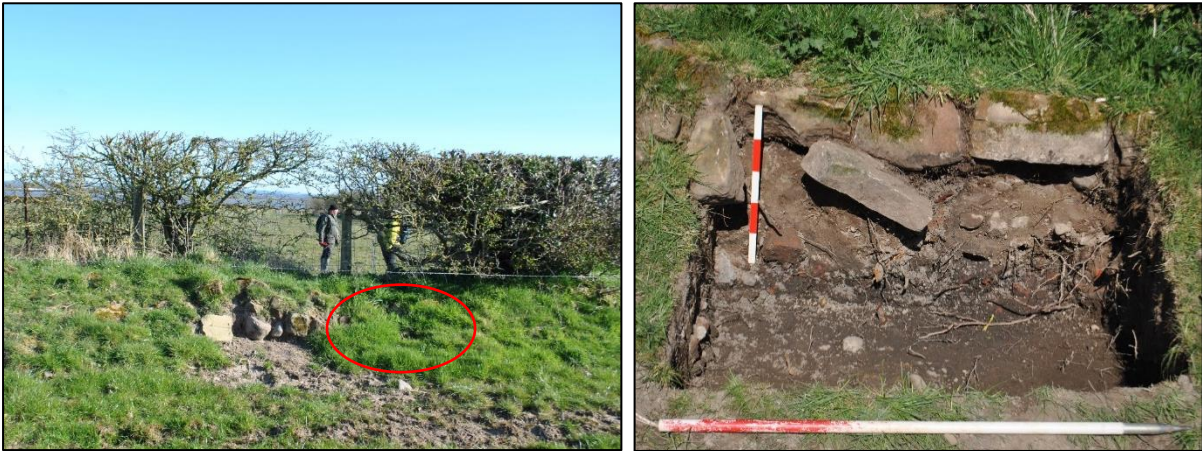
Trench 2 was sited to run SSW-NNE for nearly 1.8 metres from the lower part of the cattle-eroded bank beneath the line of facing stones up to the stones themselves. The trench was 1.2m wide. The area had been under rough turf, with patches trampled away by cattle (fig. 13).

Fig. 13: left, Trench 2 area before excavation, looking NE; right, post-excavation, looking N

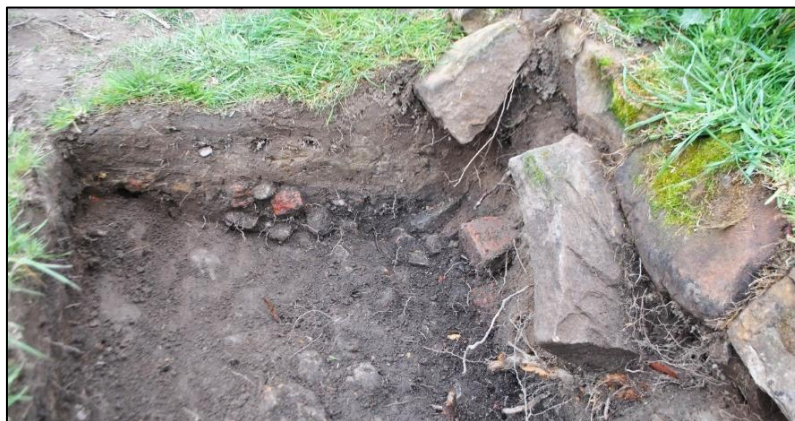
The earliest layer (2006) uncovered in Trench 2 was seen in the southern half of the trench, the northern half having been cut away by the west-east ditch/rubble drain [2005] also seen in Trench 1. Layer (2006) was a gritty, dark greyish brown, sandy silt with frequent sub-rounded pebbles but also a considerable number of larger sandstone cobbles and sandstone shatter (at least 40%). This appeared to be a subsoil containing some redeposited and spread wall core material. The layer would have been created over time as facing stones were robbed, the field bank was reshaped, and repeated ditches were cut in attempts to

Fig. 15: Trench 2 after excavation, looking near west

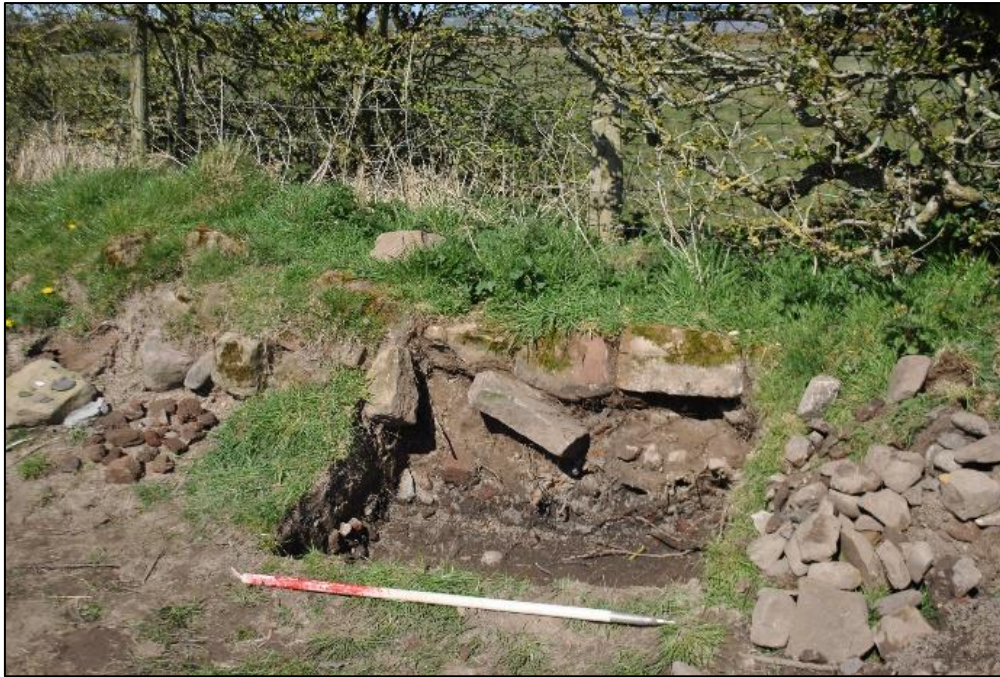
After the removal of the structure, the field bank was rebuilt using many cobbles and some larger sandstone blocks, the majority of which latter stones could have originated as wall core, all held together by clayey silt soil (2003). Finally, a number of curtain facing stones, which may already have been re-used in the building, were lined up along the bank to complete the restructuring [2004]. Four of these were visible, three at the top of the trench and one to their immediate west. The three stones in Trench 2 were similar in size to those recorded in the *in-situ* courses to the west by the field gate, averaging at around 0.3m long by 0.18m high. However, the stones were either not re-set in the bank with the front faces outwards or they had twisted in settling and/or been disturbed. Only the stone to the immediate west and most eastern of the stones in the trench might be facing approximately the right way.

Fig. 16: Trench 2 after excavation, facing NNE
