**Report on Conservation Work carried out at Cat Stairs and Peel Gap (SM listing: 1010966) in 2020 as part of the WallCAP Project**

**Jane Harrison**

### Application for Scheduled Ancient Monument Consent, repair to a failed section of Clayton wall face at Cat Stairs between turret 39a and milecastle 39

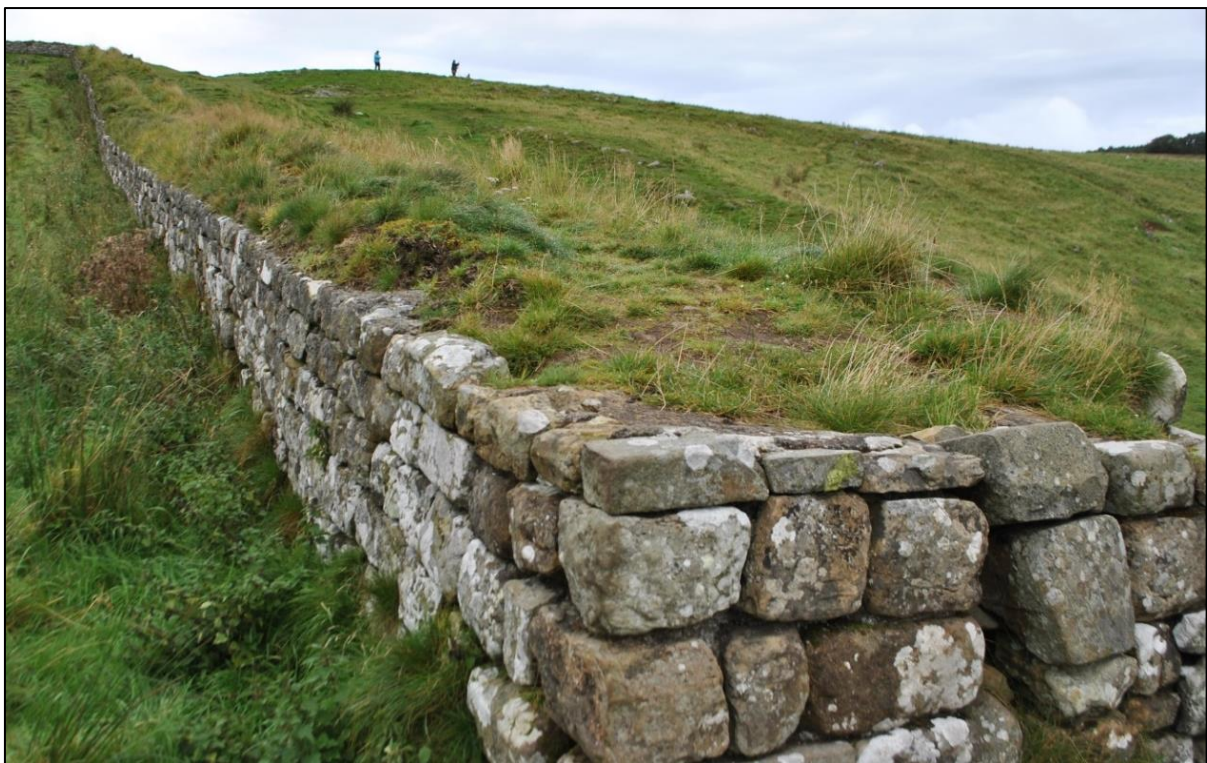
The surviving section of Clayton Wall, from where it butts the stone dyke running north-south alongside the minor road up to the Steel Rigg carpark (NGR: 3750667 567589), east and south-eastwards to the field gate into the Peel Bothy field (NGR: 375278 567503), is often walked on by visitors and there are several places used regularly for climbing up onto the Wall (e.g. fig. 2).

**Fig. 2: signs of erosion on the wall top on the northern side of the field gate into Peel Bothy field, looking north, October 2020.**

The opportunity was taken both to repair the two collapsed stretches, according to the parameters laid out in the application for SMC, and to consolidate and reprofile the often-walked stretches of wall top with turf and stones to deter visitors from climbing up onto and walking along the curtain. The work was undertaken by *Heritage Consolidation* in October and November 2020 as part of the WallCAP project. An archaeological watching brief was maintained during the repairs.

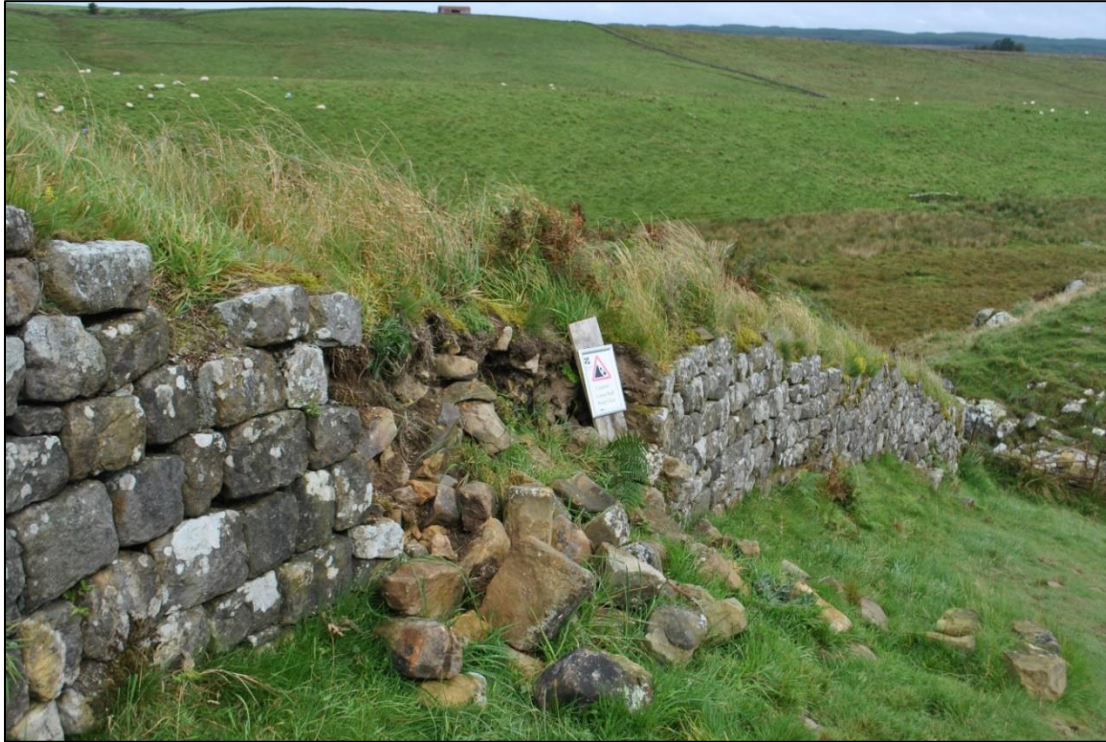
However, the localised problems included a recent collapse of the south facing courses of the Clayton Wall at Cat Stairs (NGR: 375846, 567697). This was the subject of a National Trust Scheduled Monument Consent (SMC) application in April 2020 (Appendix C). A further failure of the Wall’s southern face had taken place in the Peel Bothy field in Peel Gap (NGR: 375253, 567534), some 600m WSW of the Cat Stairs collapse (fig.1).

**Fig. 3: the collapsed section at Cat Stairs, looking north, October 2020**

The National Trust 2020 SMC application sought consent to dismantle and rebuild the collapsed section of the southern wall face, reinstate fill behind the face as necessary, and re-bed and augment the turf capping.

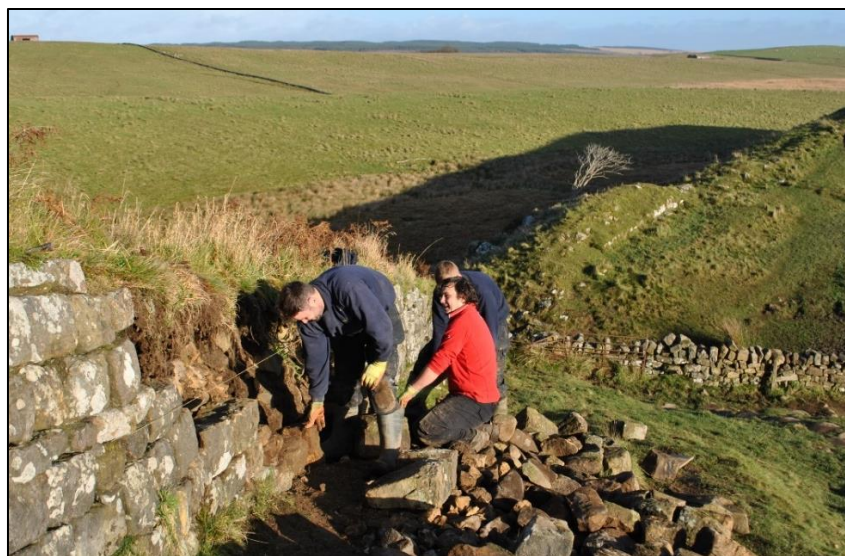
**Fig. 4: Cat Stairs under reconstruction**

The Cat Stairs collapse was of a stretch of the Clayton Wall that had clearly been repaired relatively recently as Terram was discovered in the wall core once the tumbled and loose stones were shifted.

1. The slumped stonework was dismantled until a stable course was reached;
2. The curtain was rebuilt using agreed techniques, including tail-bedding as necessary; and
3. The top was consolidated using the turf plug method: just over five metres of Wall were affected.

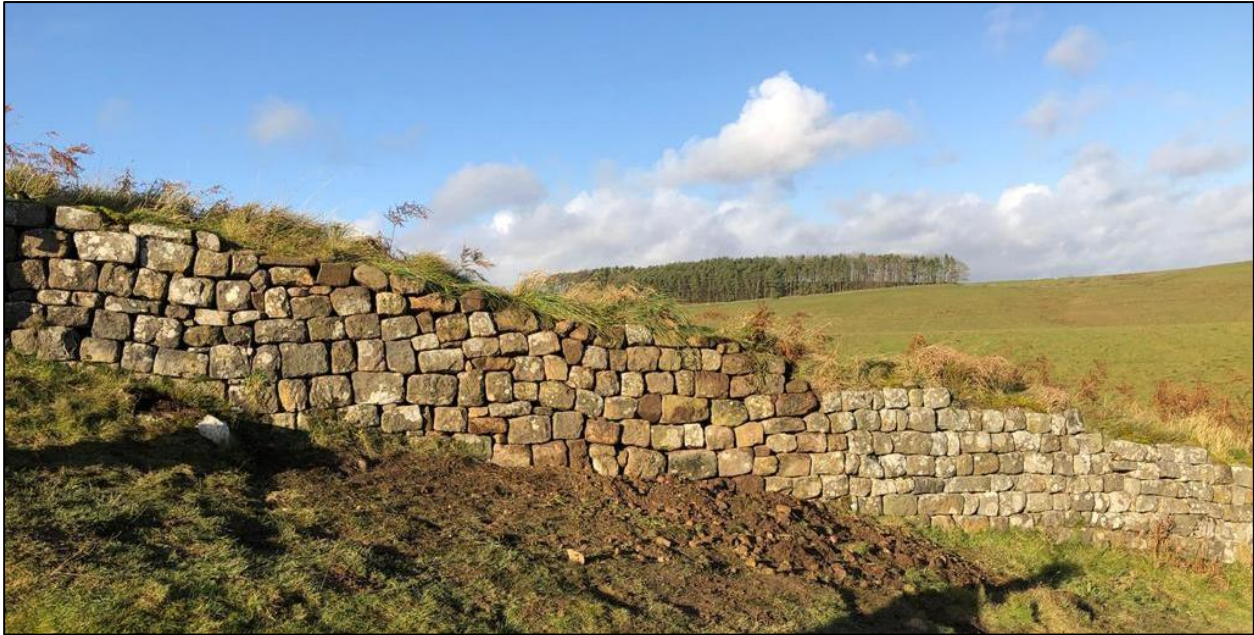
No undisturbed Roman courses were revealed and the only find was a 2012 one penny piece. The archaeologist's site report is appended: Appendix A.

**Figs 5: Cat Stairs, conservation complete, looking north-west**

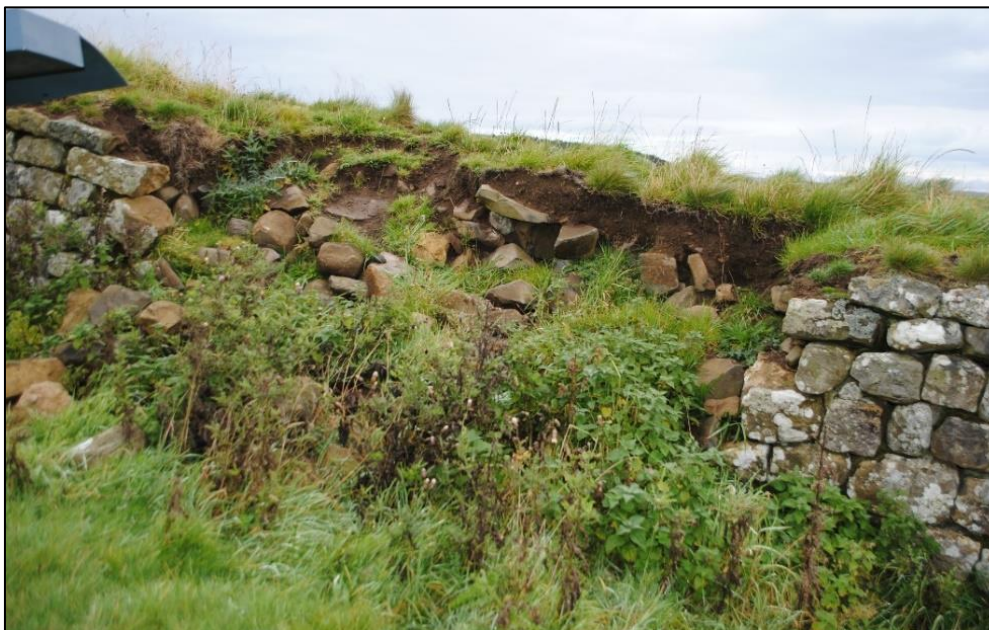
**Fig. 6: the failed section in Peel Gap, west slope, October 2020 looking north**

1. At the Peel Gap, west slope collapse: the slumped stonework was dismantled until a stable course was reached; the curtain was rebuilt using agreed techniques, including tail-bedding as necessary; and the top was consolidated using the turf plug method. Around six metres of Wall were affected.
2. Stretches of curtain top – as indicated in figure 7 – were consolidated and re-profiled (figs 8 and 12); some 70m of the curtain were involved in total. The work at the gate into the Peel Bothy field also included repairing the ordinary stone dyke forming the south-eastern side of the gate.
3. The stone field wall running north-south to Steel Rigg carpark was raised to deter people from climbing onto the end of the Wall from the road to take photos (fig. 9).

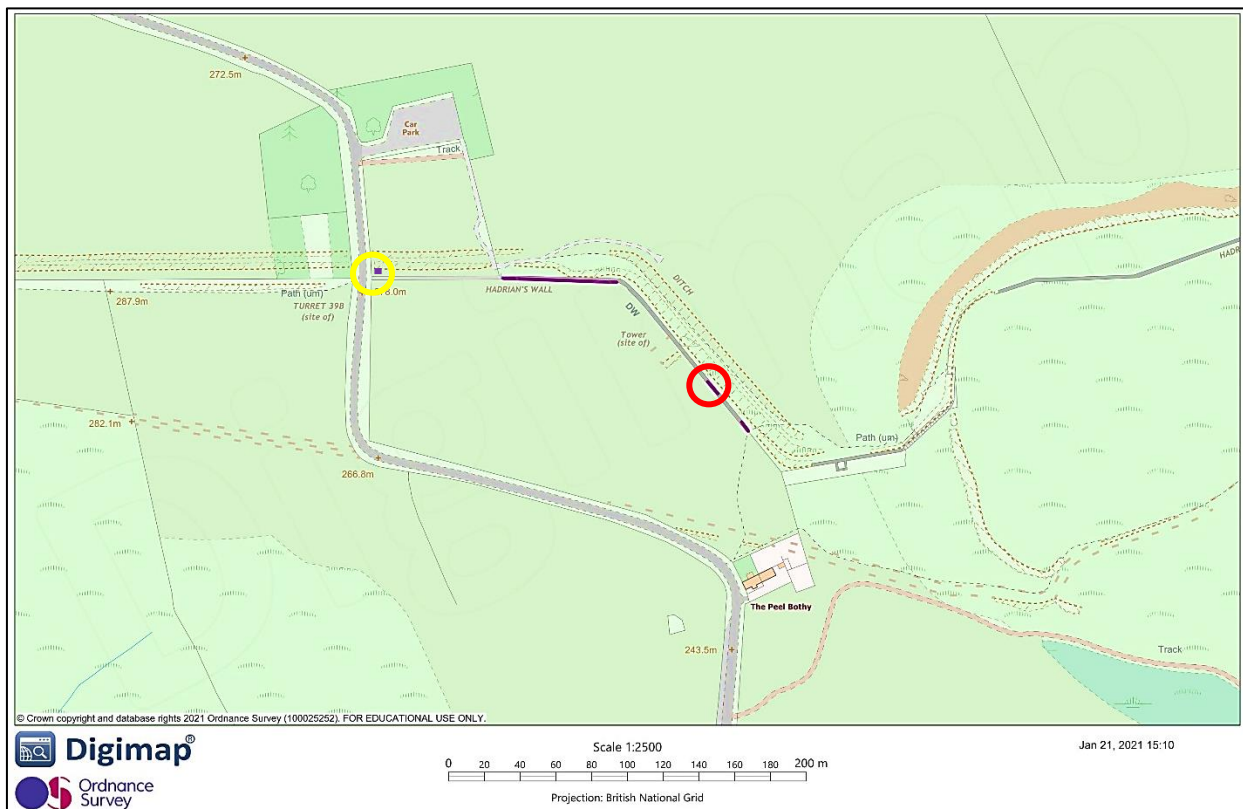
**Fig. 7: Peel Gap: the purple lines show locations of turf and stone reprofiling, red circle the location of curtain Wall re-building and the yellow circle the location of the north-south stone dyke raising**

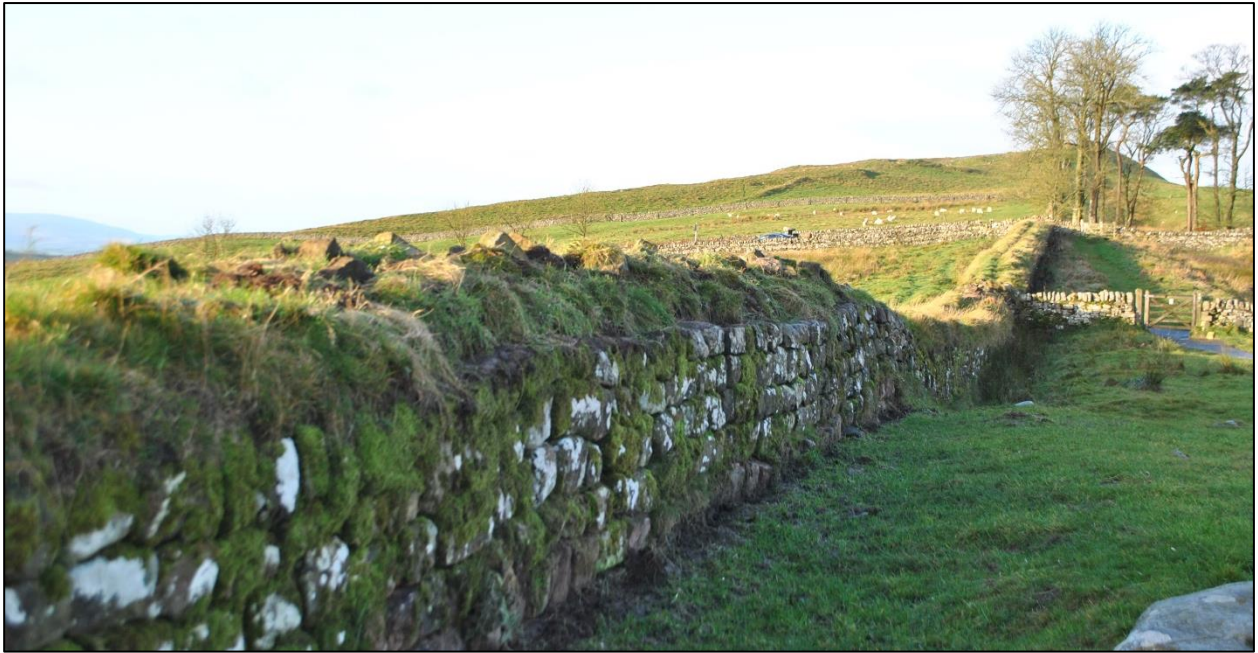
**Fig. 8: reprofiled section of curtain, looking south-west.**

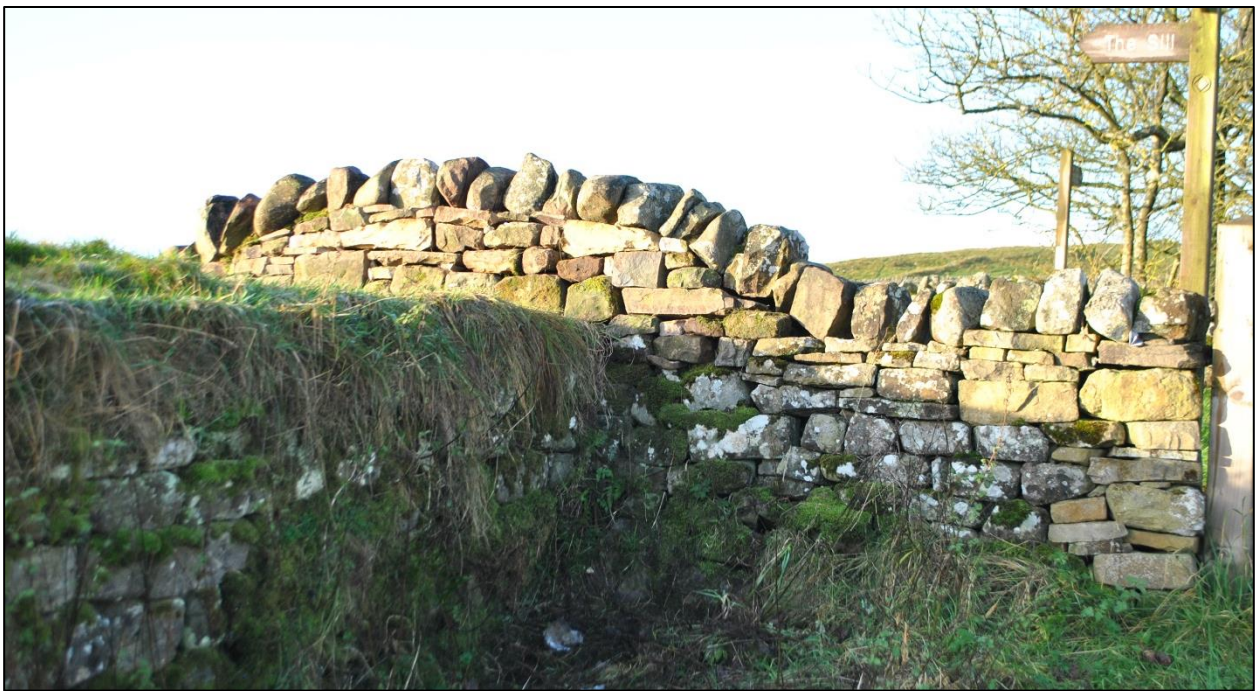
**Fig. 9: raised and re-shaped stone field wall, looking south-west**

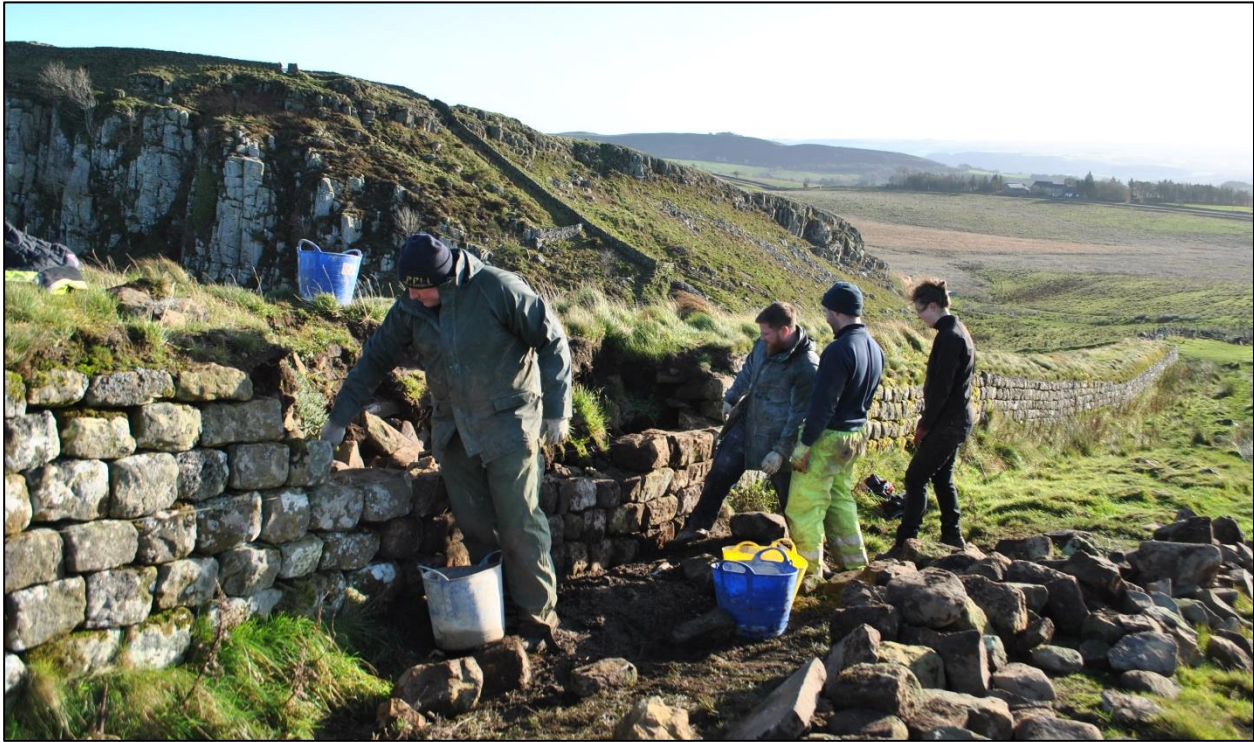
**Fig.10: rebuilding at Peel Gap, west slope, looking east**

The collapsed section of the south face of the Clayton Wall in the Peel Bothy Field was dismantled down to a secure foundation course of larger stones, which was probably undisturbed Roman fabric. Mortar was discovered on the tail ends of three of these large foundation stones and a sample was taken. No other finds were made. The curtain was rebuilt from that secure base and the top reprofiled with stone and turf (figs 10 and 11). The archaeologist's report is attached as Appendix B.

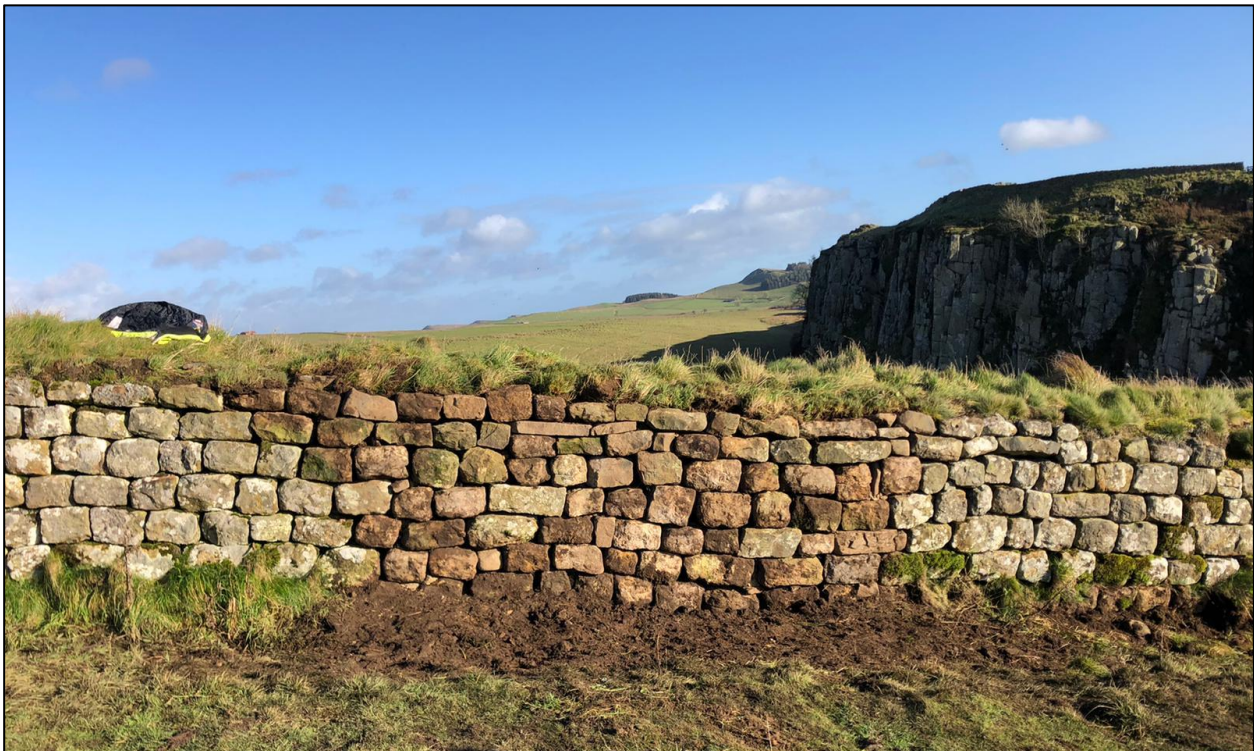
**Fig. 11: Rebuilding and reprofiling complete at Peel Gap looking north-east**

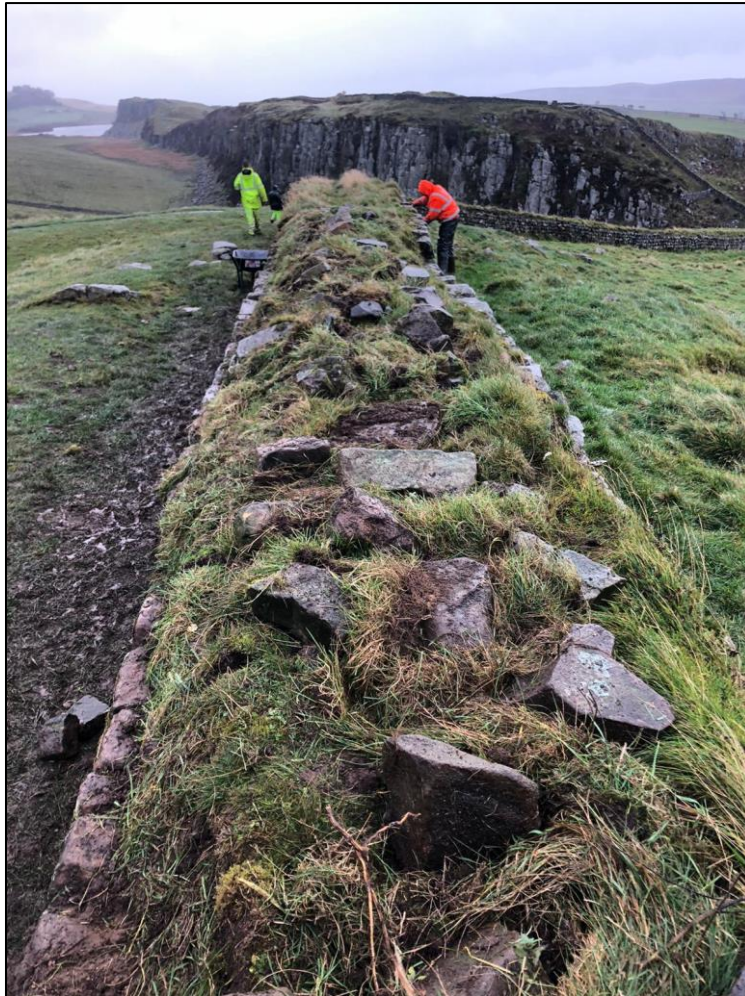
**Fig. 12: Peel Gap west slope, reprofiling underway, looking east**

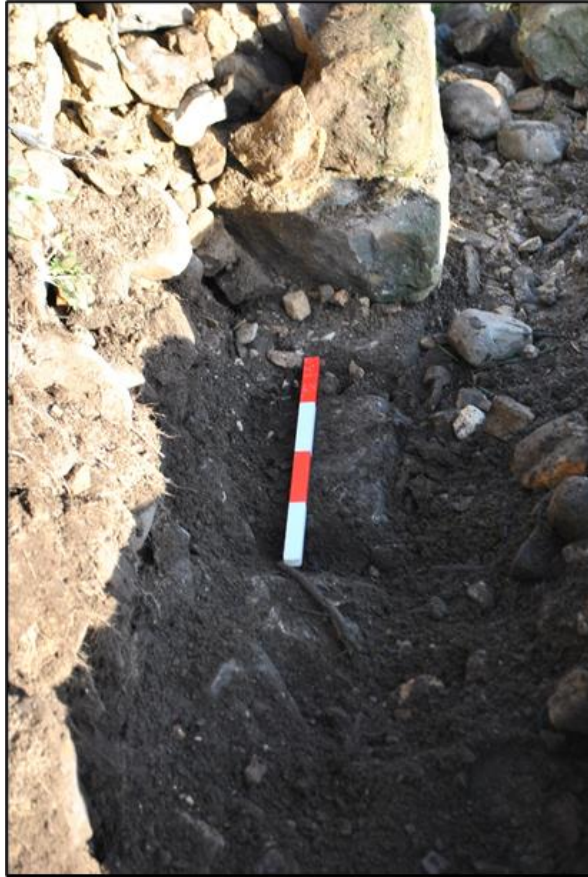
Serious collapse of south-facing facing stones and wall core. In the west of the exposed wall core terram was revealed – white/clear non-breathable – and visible dropping down over an area of core and lapping down to just above the secure course at which the *Heritage Consolidation* team stopped dismantling. A modern repair had clearly collapsed; it was unclear whether the course in the photo below was Clayton work or original but observing the fall of the ground there were probably at least two further courses below the one revealed and the former is more likely. There was no reason to dismantle further. A 2012 one penny piece was found.

**Fig 1: Secure course at which dismantling stopped, looking north-east**

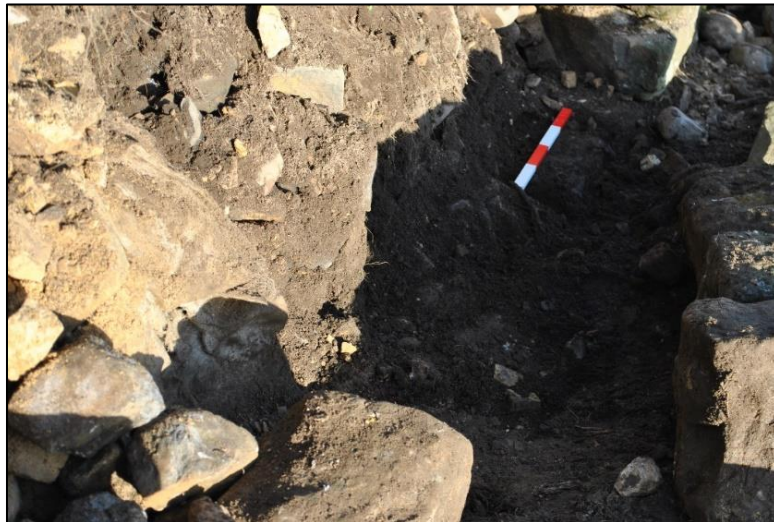
**Fig 2: Terram visible to left of photo, looking north-east**

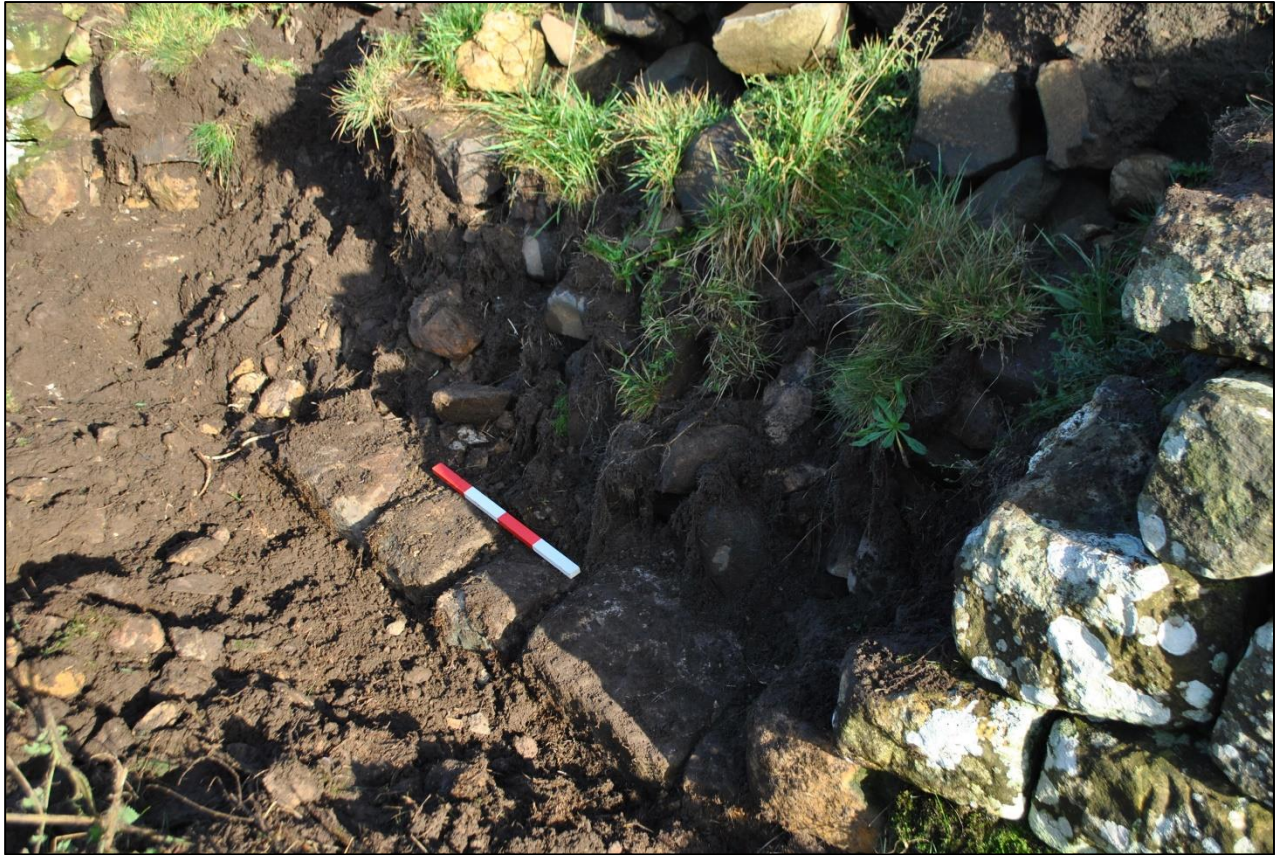
South face collapse of at least four courses of surviving Clayton wall. Dismantling was needed of a further five stones of the course at the base of the collapse as they had slipped out and canted

downwards as the wall bellied under the weight of the core and previous reprofiling (fig. 1). This course may have been surviving Roman fabric pushed out of position by the slump of Wall fabric.

**Fig. 1: slipped course of stones, looking north**

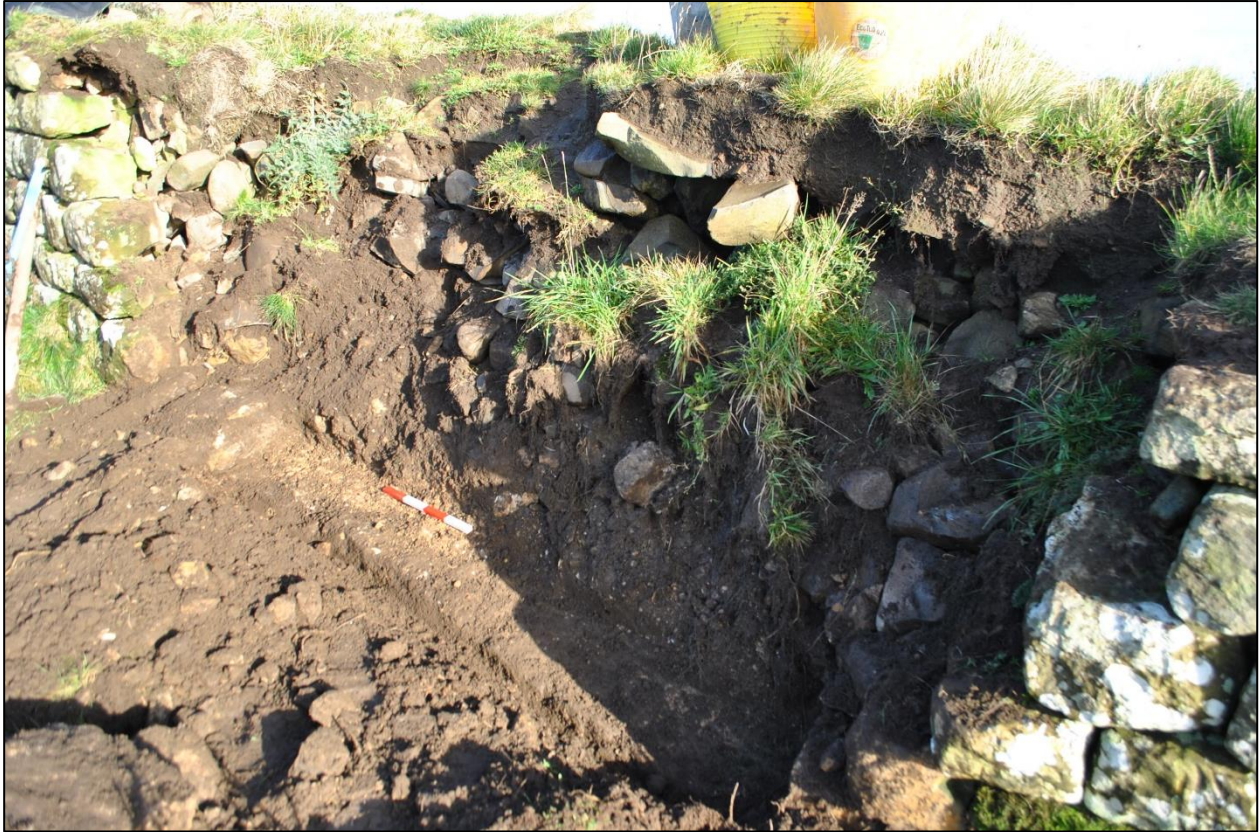
Below the slipped course were four larger stones, exposed to a depth of c. 0.25m. The length of the furthest west stone was not fully exposed but 0.5m was visible, the next stone east was 0.62m long, the next 0.47m long and the furthest east, again not fully exposed, was 0.4m long. These stones were completely secure and were larger than the majority of the stones used in the courses above. This course may well have been foundation and was almost certainly *in-situ* Roman construction. There appeared to be some contemporary mortar surviving at the back of the exposed stones, c. 0.15m in from the faces (fig. 2).

**Fig 2: the sound course of probably undisturbed foundation stones with mortar visible, looking north-west**

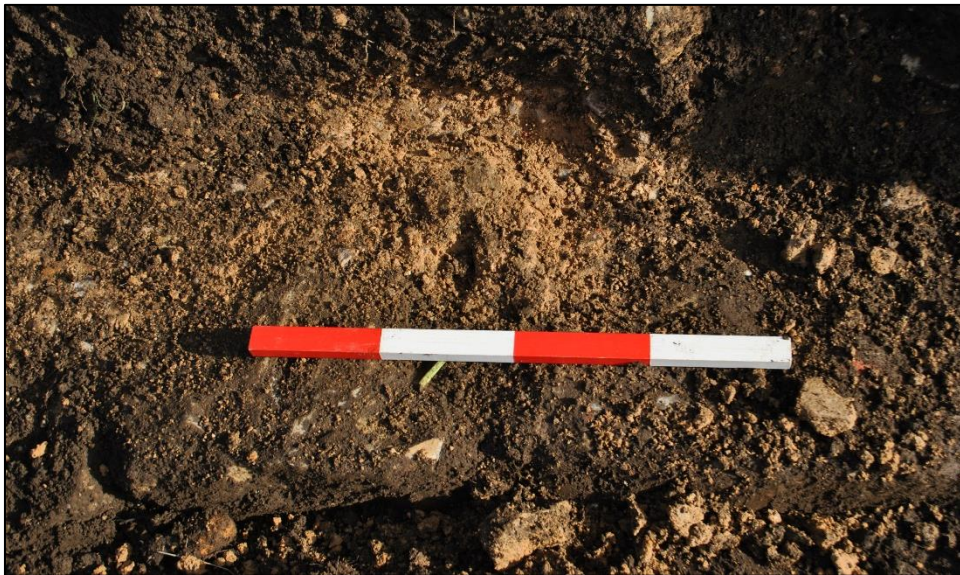
The mortar had many inclusions including white and CBM-red coloured fragments and was an orangey pink colour on exposure. Silt had washed down from the wall above, but lenses of the mortar seemed to be relatively undisturbed, with the silt only on the surface (fig. 3). A sample of mortar was taken. The section was rebuilt up from the sound course of larger stones.

**Fig 3: the mortar and large foundation stones, looking north-east**

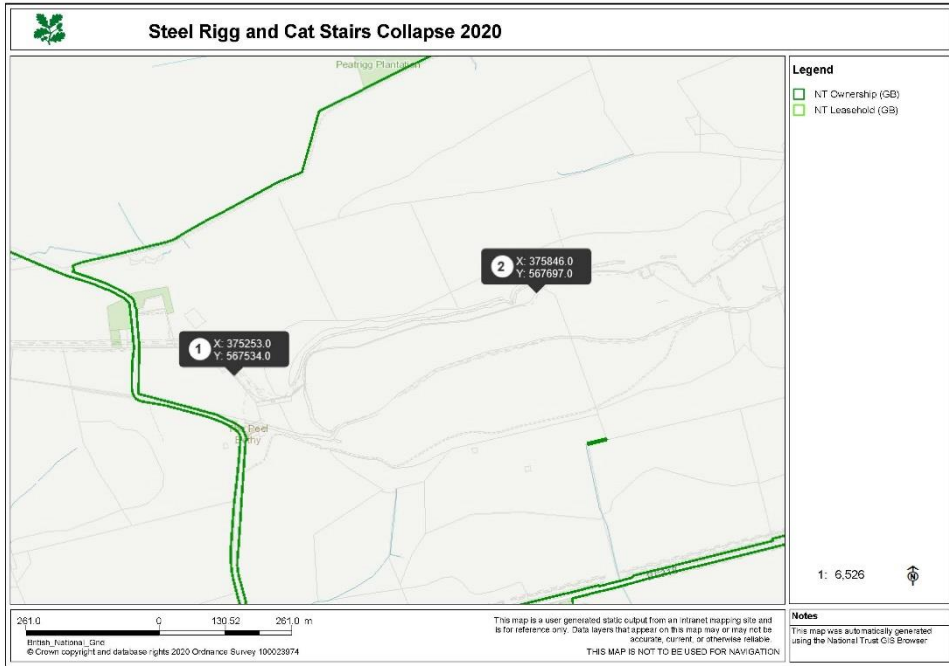
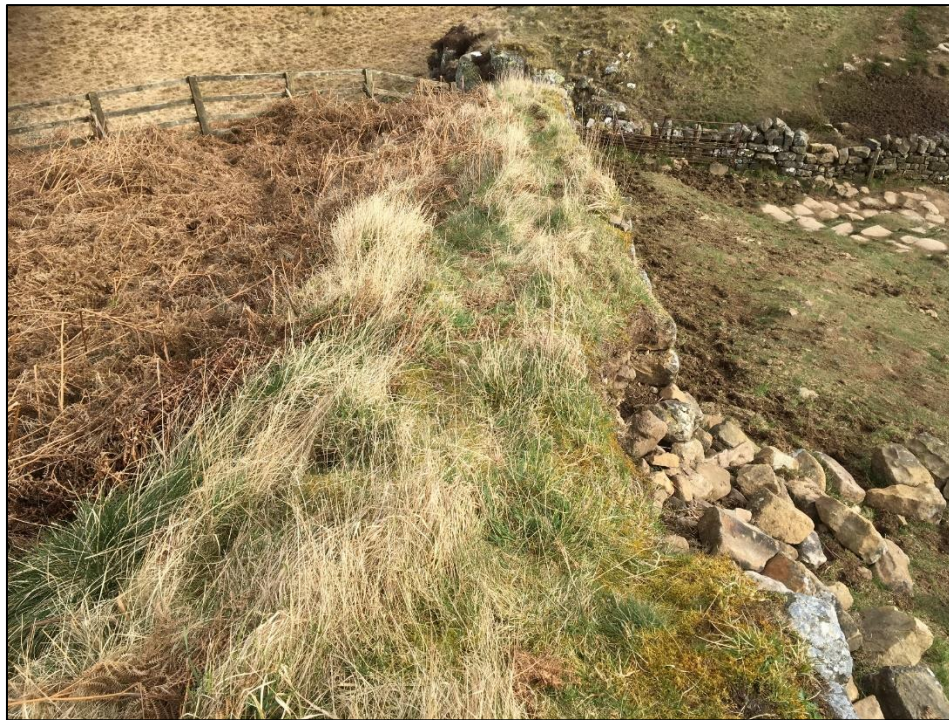
In 2019 this section started to fail. Repair works were deferred until an HMA for management of the NT owned section of Hadrian's Wall could be agreed, but given acceleration of decay over winter, a separate SMC application is now submitted.

**The failed section facing east**

This application seeks Consent to dismantle and rebuild the failed section of the wall face to high professional standards, and reinstate fill behind the face to re-bed the turf capping.

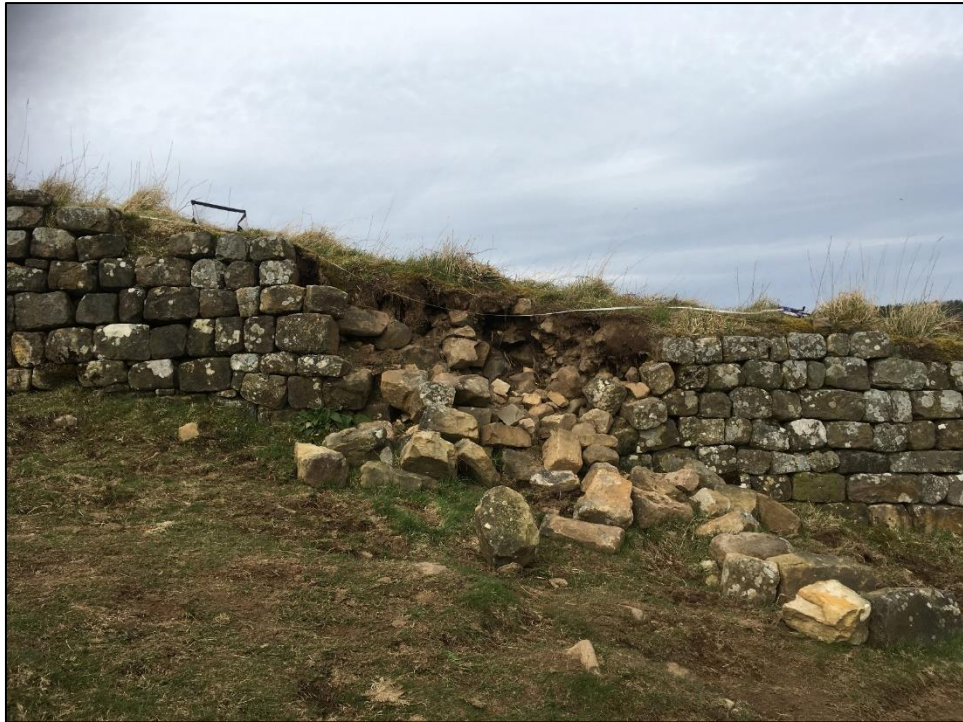
**The failed section facing north**
