# Walltown Crag, Hadrian's Wall, October 2020: WTC20, excavations across the Wall

Jane Harrison and Kathryn Murphy

## Hadrian's Wall Community Archaeology Project (WallCAP)

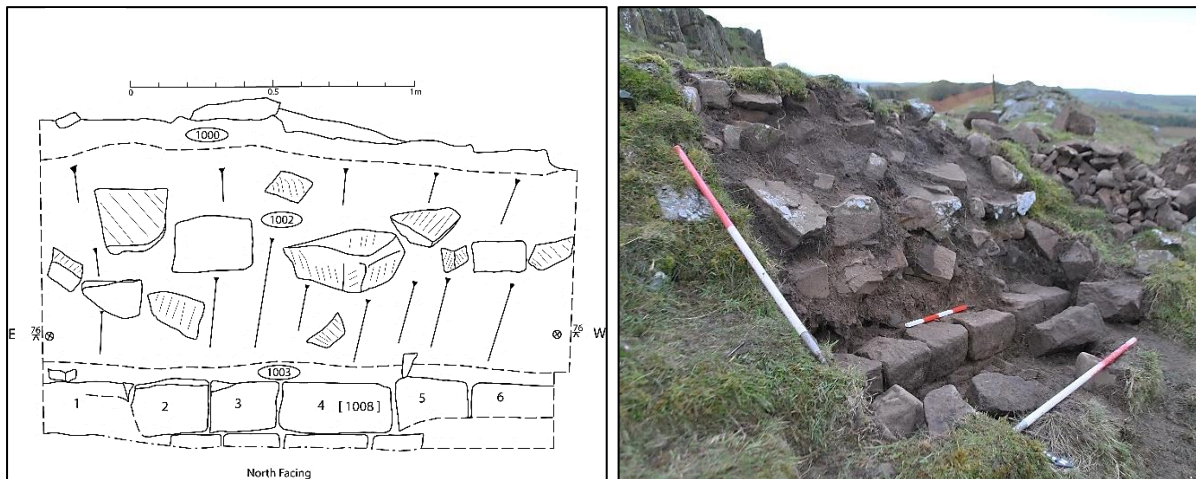
**Fig. 8:** left, Trench 1, north of the Wall, north-facing Section 1.0; right, Trench 1 after excavation looking south-west

The layers across the Wall core to the north and towards the base of the north face of the curtain were unpicked carefully. Underneath the turf, rubble and topsoil of (1000), a layer of slipped and collapsed core material (1002) of uneven depth was removed across an area 0.6m north-south by 0.9m east-west over the core and in front of the north face of the curtain, to expose the top of the uppermost surviving course of facing stones. Stones in (1002) were up to 0.35m long, a few were worked, the majority were around 0.25m in length, with the smallest ones around 0.1m. More of the larger stones were found in the east of the trench closer to the bend. Below this, over the facing stones was thin layer of gravelly sandy silt (1003) with a good deal of moderately sorted smaller pebbles and grit and very few larger stones. This appeared to be degraded core material under the collapse and slippage of core materials that had accumulated over the *in-situ* facing stones below. The collapse of core material from the curtain was greater to the north than to the south in Trench 1, and this can be explained by the proximity of the steep crags and the absence of more facing stones from the north face.

One complete course of the northern face of the Wall was uncovered in Trench 1, and the top 0.05m of the course below [1008]. As to the south, the courses were formed of squared rubble sandstone blocks. For the six stones of the upper course completely revealed, heights ranged between 0.17-0.19m and widths between 0.24-0.34m. The stones of the top course were more somewhat more weathered than those of the south face. Deliberate robbing aside, this crag-edge face had collapsed to a lower level than the southern one, with much of the core and any remaining facing stones having fallen down the face of the crag. Comparing heights above sea level of the top course on the north face with the upper complete course on the south side it is likely that the foundation course survives beneath the partially visible course. The top of the uncovered north face course was at ~250.45mOD, that of the upper near-complete course on the south side at ~251.00mOD; on the south side a level of 250.45mOD would be neatly located at the top of the second course above the foundation course. There was no evidence for repair or bonding of the north face, unless the thin gritty layer of (1003) was in part created by the decay of sandy bedding mortar.

In general, the character of the collapse north of the Wall had differences from that south of the Wall. The north face is more exposed to the force of wind and rain and much of the material removed or collapsing from the Wall would be lost down the face of the rapidly steepening crag. At least three more courses had been lost from the north face than to the south, and there may have been more slippage and gradual slumping of facing stones to the north. However, the considerable height of exposed core material – around a metre – partially consolidated by turf, moss and small plants seemed to be holding up reasonably well, although it will undoubtedly be gently deteriorating without the protection of the facing courses.

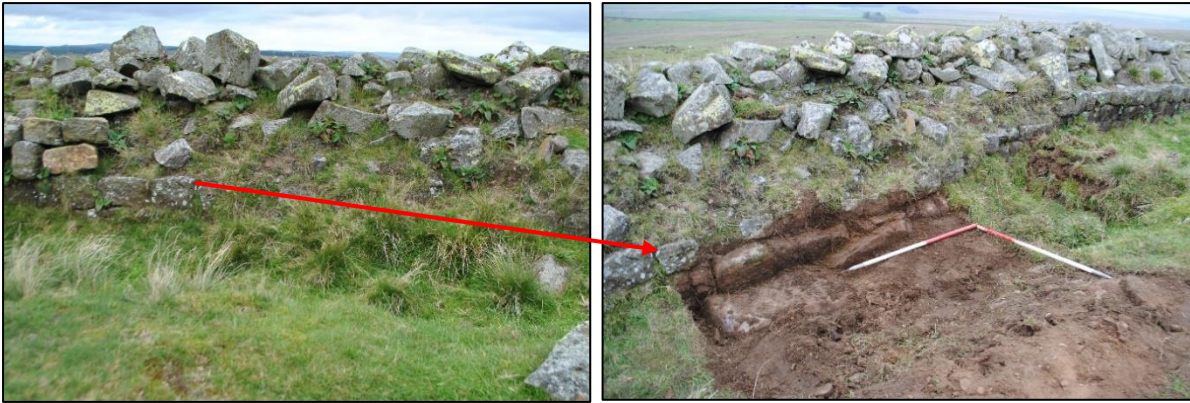
Fig. 9: left, Trench 2 before excavation looking NW; right, excavation underway looking N

Trench 2 was sited to run NW-SE from the top of the Edwardian spoil bank running parallel to the curtain wall, down across the excavation ditch south of the wall and up to the face of the curtain. In this area the patchy turf and moss growing amidst the exposed core on the wall had merged with the rough, thick grass of the ditch below to obscure the facing stones more visible too either side of the section (fig. 9). The trench was two metres square with southern half of the trench being the spoil bank and the northern half the shallow ditch. Turf and moss were not removed from around the core so as not to further de-stabilise the top of the wall: excavation began at the top of the surviving courses of Wall.

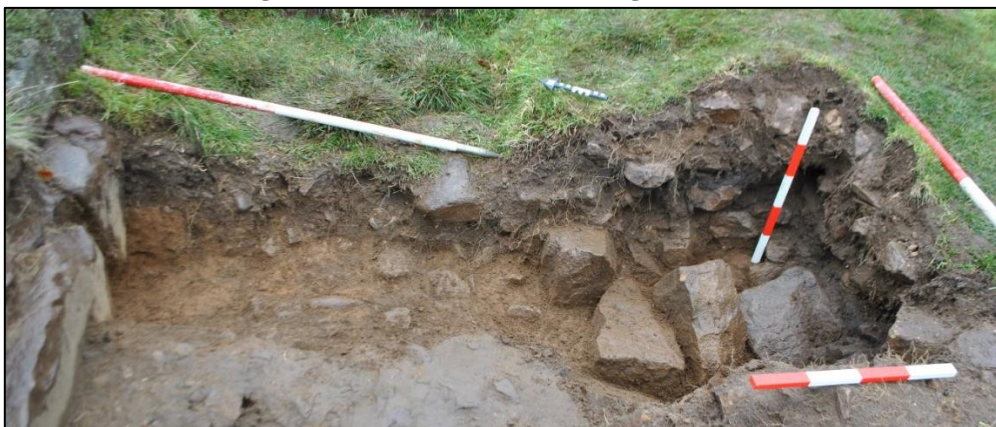
**Fig. 11: Trench 2 after excavation, looking north-east**

In the southern half of the trench turf (2002) was preserved beneath the spoil bank created during the Edwardian excavation. The two-metre wide linear bank runs parallel to the curtain wall for just over 30m at about one metre from its southern face. In the slot excavated across it in Trench 2 the bank was between 0.2-0.25m deep, diminished by slump and walkers' and animals' passage. Around half of the bank-material comprised poorly-sorted stone, with only two larger stones amongst them. The spoil was probably mostly core material; the earlier excavators may have removed any more useful facing stones dug out from the tumble. Digging the shallow Edwardian ditch to the north of the bank had removed not only the contemporary turf (2002), but also the accumulation of pre-Edwardian collapse and disturbance (2003), and probably some of subsoil/backfill (2006) below.

In the century that followed the ditch had slowly and partially refilled with sandy silt (2005). This deposit was 0.25m deep against the Wall and thinned to the south-east downslope, and formed mostly of smaller stone tumble and core material with patches of decayed turf amidst the soil and stones. The layer also likely contained drifts of material from the spoil bank to the south. Over the spoil bank and the tumble to the north, a rough, reed-rich and mossy grass has grown over sandy soil (2000). This topsoil layer was also very stony: mostly smaller stones but with occasional sub-rectangular stones up to 0.3m; the area over the soil bank was stonier than to the north.

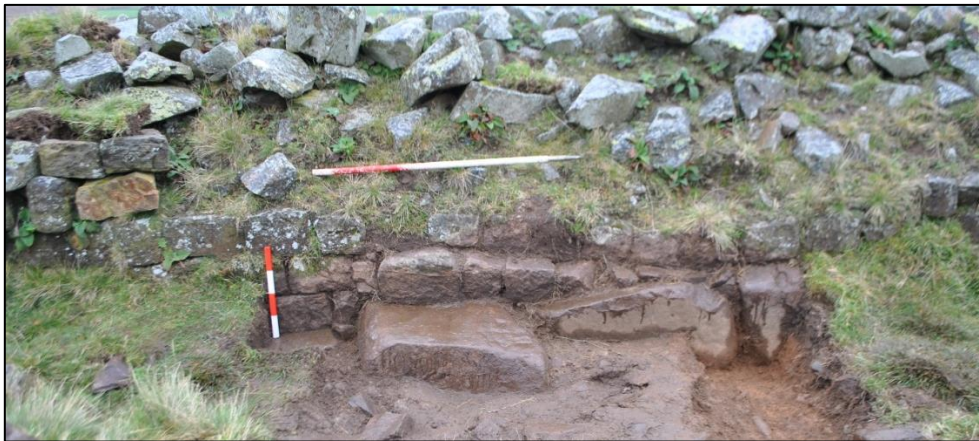
**Fig. 13: Trench 2, curtain wall, looking north-west**

Up to three courses of the Curtain were revealed in Trench 2. The courses were the lowest of the Wall, with the bottom two foundation courses built directly onto whinstone bedrock. The vertically riven, jagged, uneven character of the bedrock was demonstrated clearly in the small crags rising to the south of the trenches. Four elements of that bedrock were seen in Trench 2, with smoothed and rounded edges and corners (fig. 13). The three columns of bedrock in the east and centre were higher and supported a footings course that began in the west as regular stones, reduced in the east to levelling chockstones between the higher bedrock and the course above. The lowest bedrock element in the west was less weathered and two stones were seen of a third Wall course which fitted between the lower bedrock and the foundation course above. To improve stability the foundation course over the higher bedrock protruded up to 0.15m out from the regular course above (figs 12 and 13). The stones of the highest surviving course were more regular in size (0.2-0.25m wide by 0.1-0.15m high) and slightly smaller on average than the stones of courses seen in Trench 1. The big stones of core material visible above the trench and along most of this stretch of the Wall were probably throw up onto the curtain, along with some facing stones when the clearing was done for the Edwardian work.

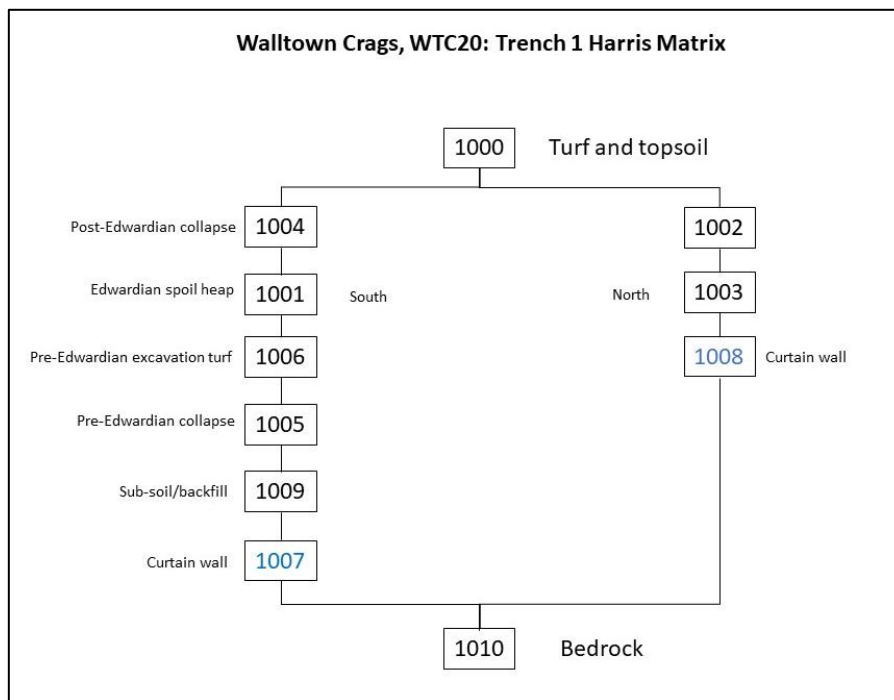
**Fig. 14: Trench 1 Harris Matrix**

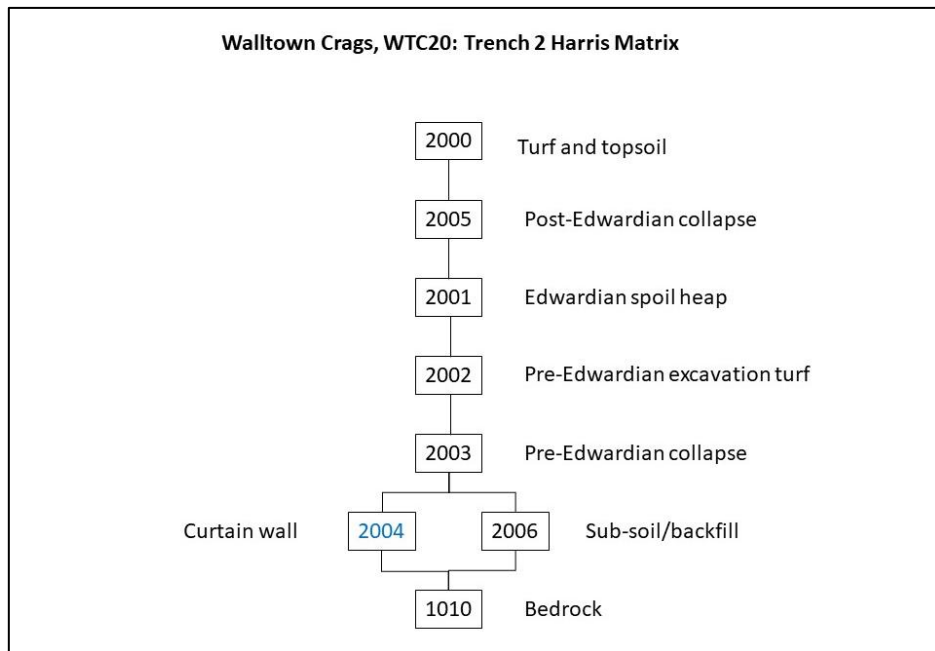
**Fig. 16: Trench 2 Harris Matrix**

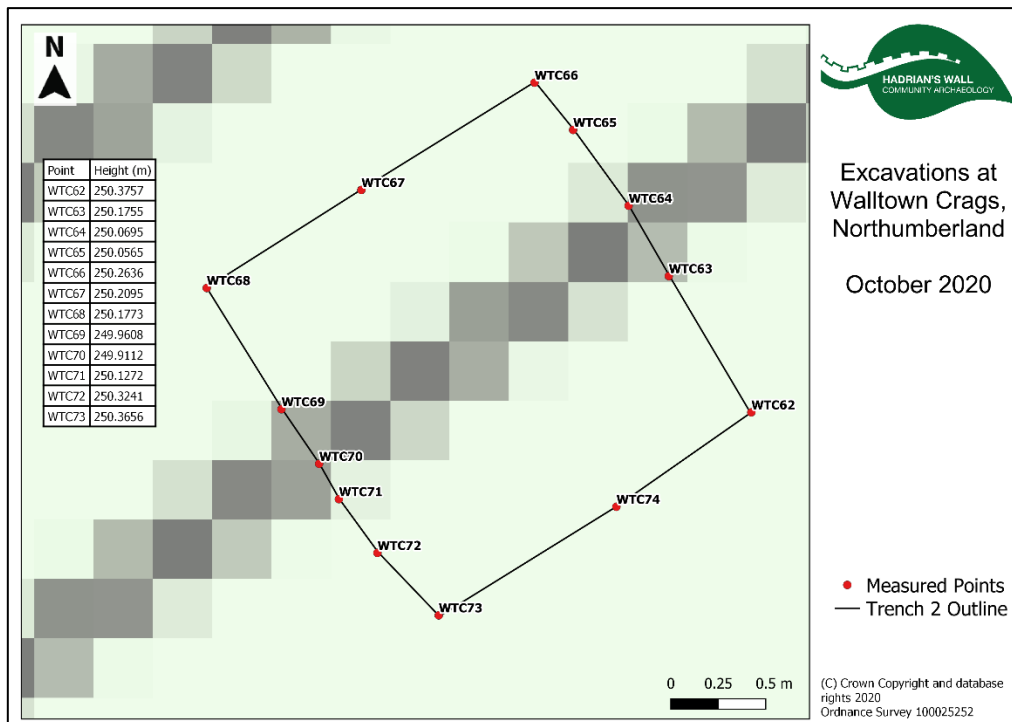
**Fig. 17: Trench 2 outline with levels in m**
