## **Heddon-on-the-Wall, Hadrian's Wall, April 2021: HW21, excavation across the Vallum**

**Jane Harrison and Kathryn Murphy**

### **Hadrian's Wall Community Archaeology Project (WallCAP)**

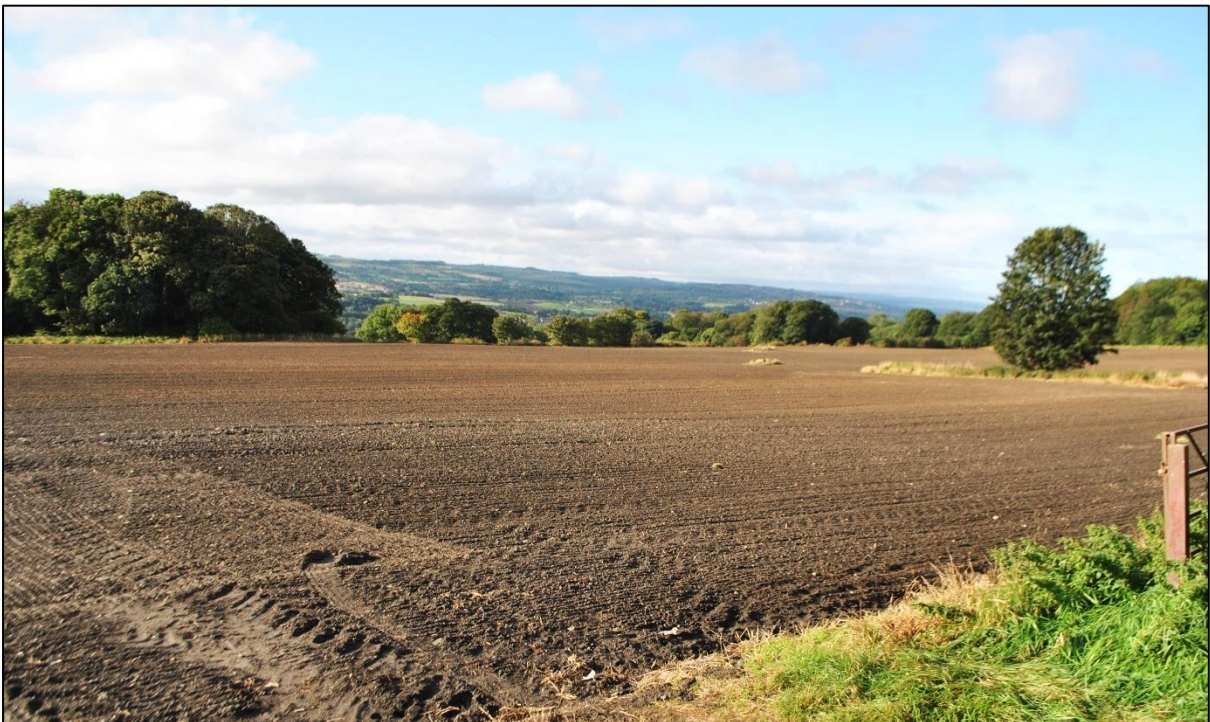
**The excavation site looking south-south-west, with the pale bands above the mounds clearly visible**

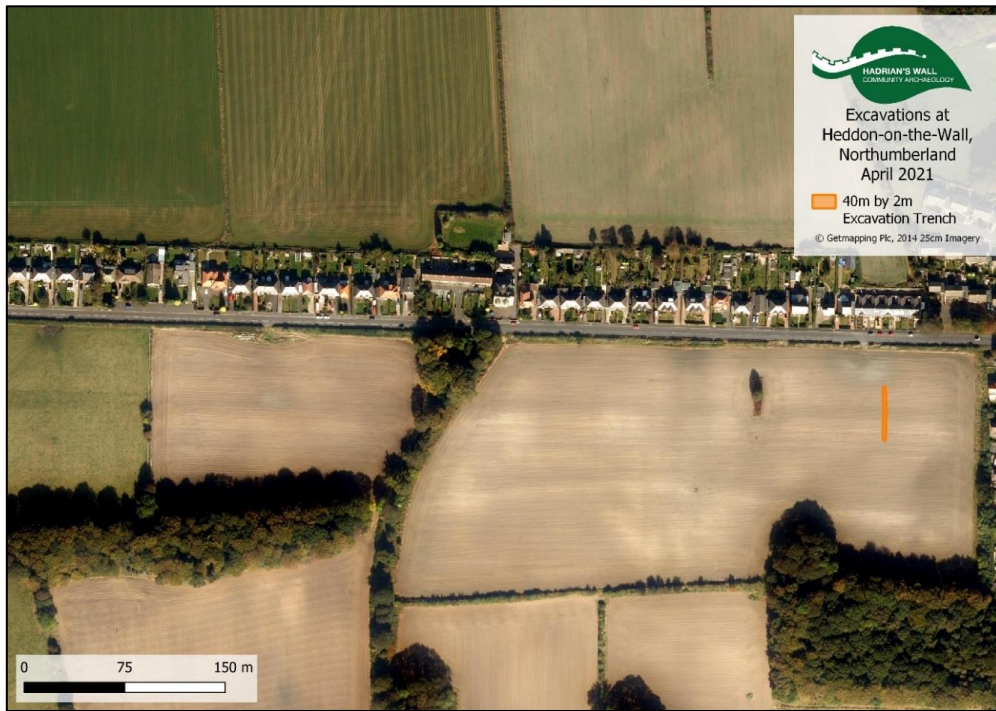
Fig. 2a: Vallum ditch and banks soil and grass marks, with the WallCAP trench in orange

completed in 2018 and it was decided the most constructive way forward was to focus limited excavation on the most easterly field, where damage to the Vallum was expected to have been greatest. This assumption appeared to be borne out by the initial surveys, which showed that the topographical expression of the earthworks was slightest, and the geophysical anomalies associated with the Vallum least clear, in that field (figs. 3 and 4; fig. 14). A trench 40 metres long north-south by two metres wide was excavated to cut across the lines of the Vallum mounds and ditch, within the area covered by the most easterly geophysics transect in the field (fig. 3). A mechanical digger was used initially; the trench was then finished by hand.

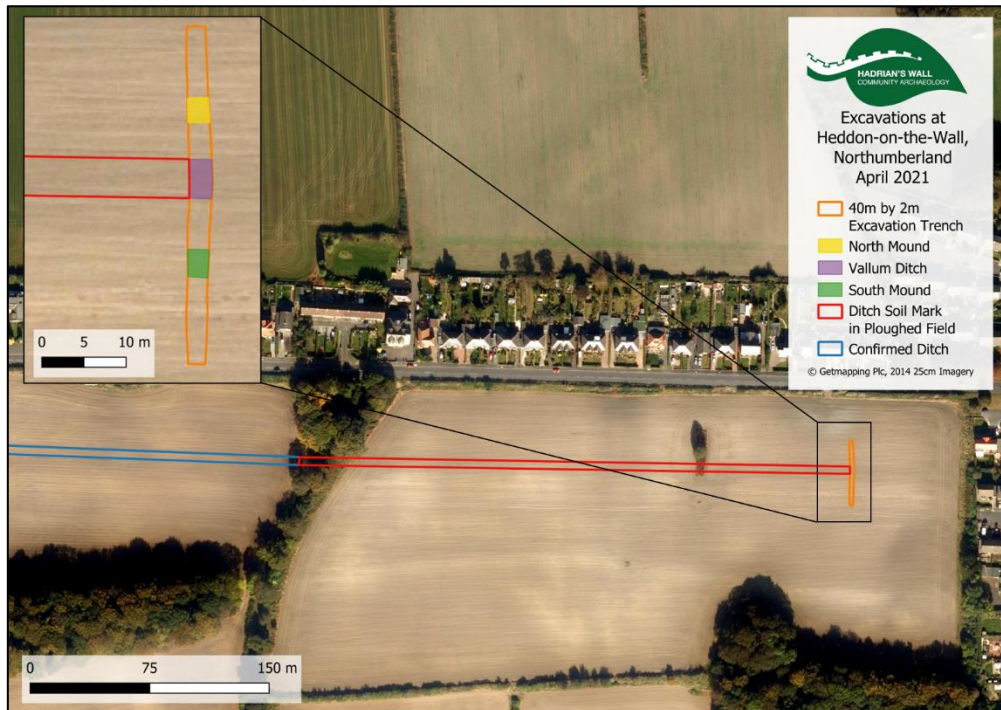
Fig 2b: Vallum ditch and banks soil marks with trench features

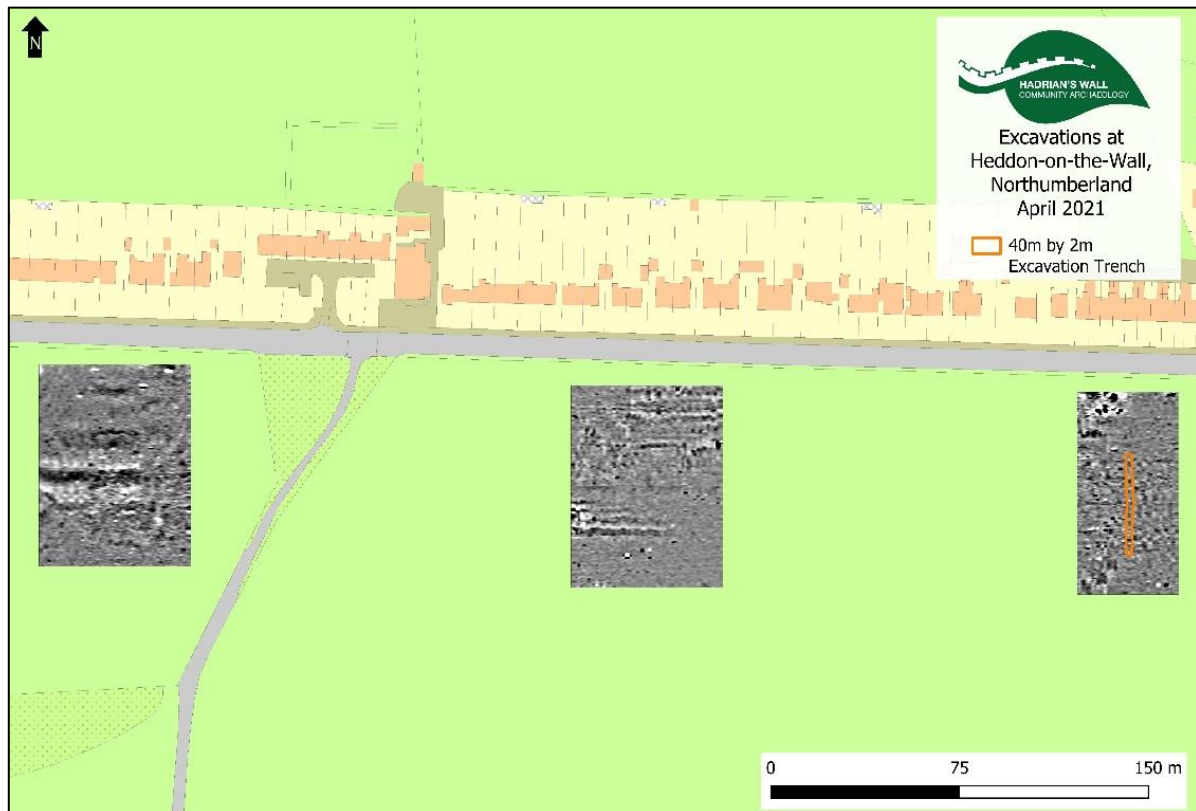
Fig. 3: gradiometry results from 2018-19. The 2021 trench is marked in orange

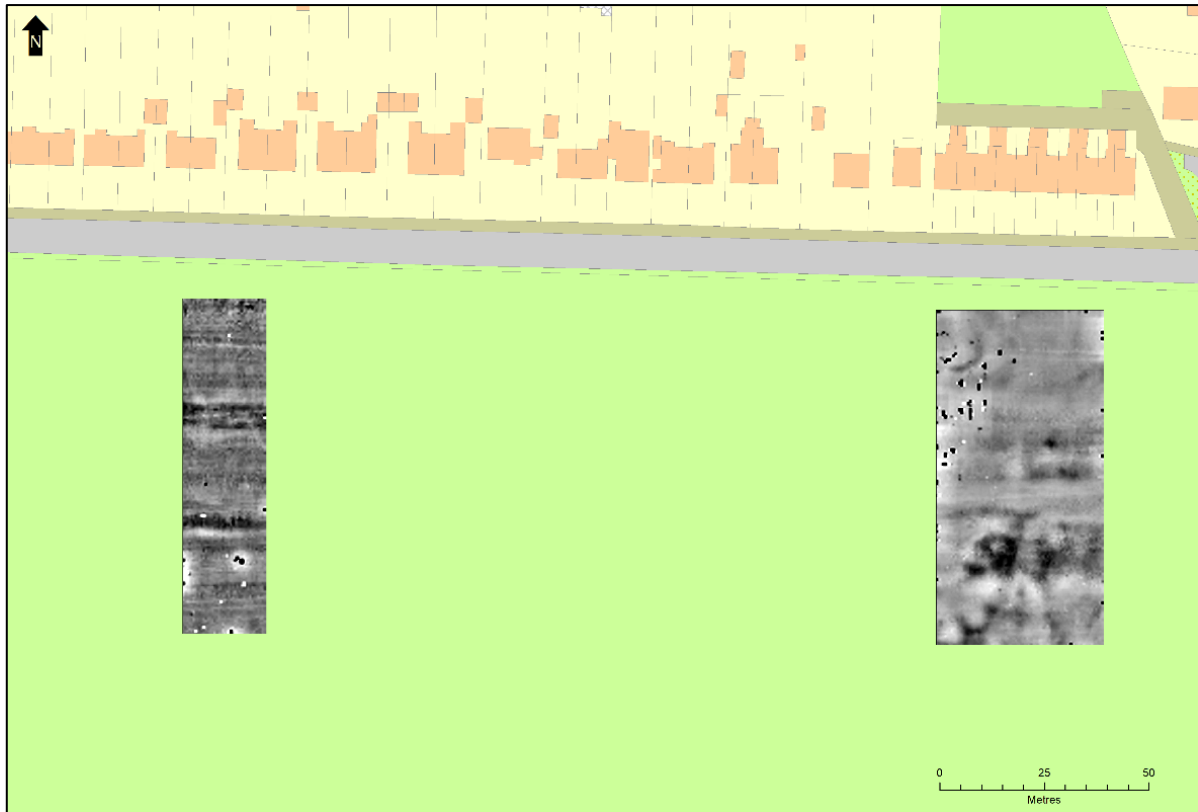
**Fig. 4: resistivity results from 2018-19**

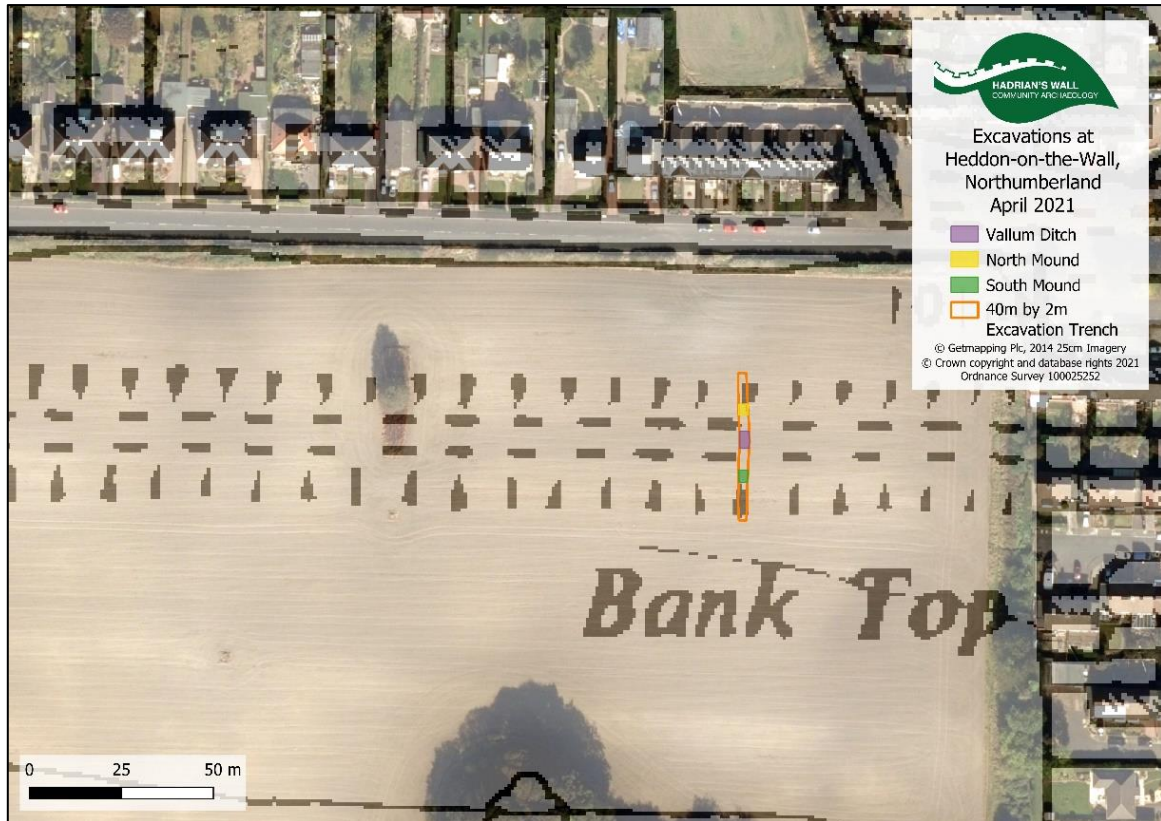
**Fig. 5: the trench location and feature plotted with historic ordnance survey mapping**

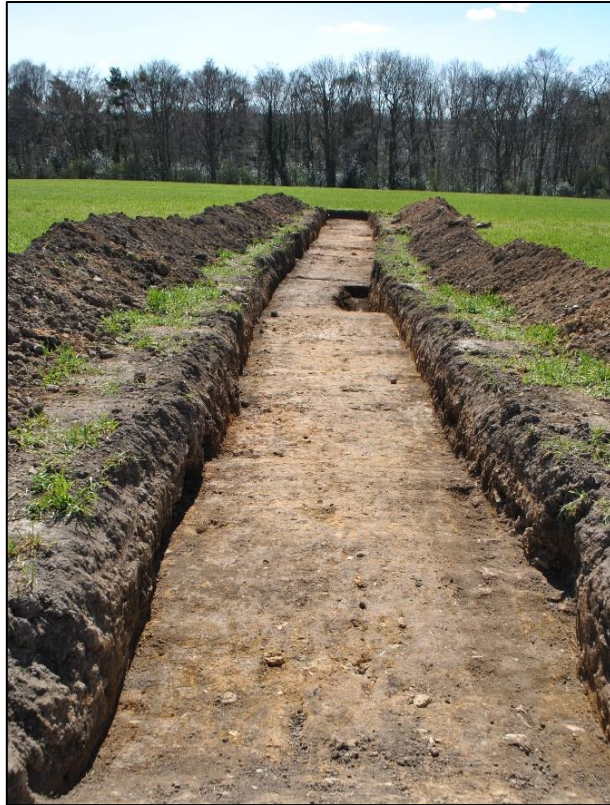
**Fig. 6: overall view of the trench looking near south**

A single, long trench was excavated by WallCAP in 2021, running forty metres north-south down the slope of the field by two metres wide (fig. 6, figs 14 and 15). The ground surface drops by c. 2.30m from the north to the south end of the trench, beyond and to the south the ground falls away more steeply. The trench was located to cut through the assumed lines of the ditch and mounds of the Vallum complex. A mechanical digger with a metre-wide, toothless, sharpened ditching bucket was used to dig down between 0.5-0.7m to the interface with undisturbed upper geological layers. This interface was seen throughout the trench except where the fill of the ditch was located. In that location a sondage was dug against the east-facing section of the trench to investigate the ditch. This intervention, reaching 1.5m from the current ground surface, allowed the recording to that depth of the Vallum ditch profile and an environmental sample to be taken of ditch fill.

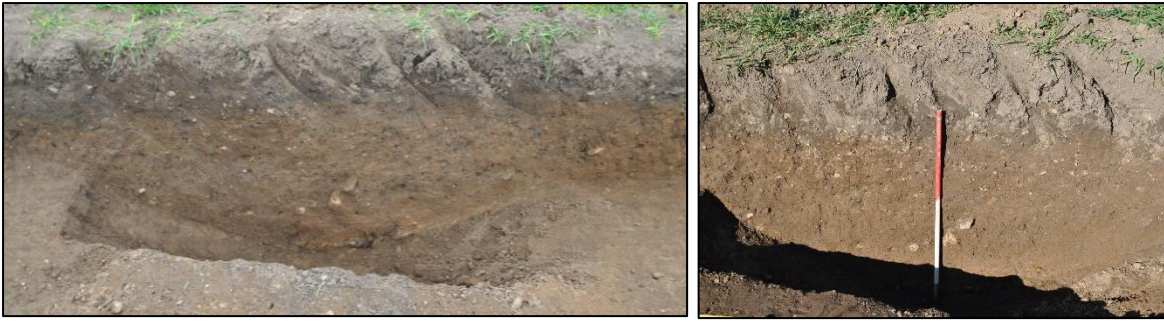
**Fig. 7: west facing photo of the ditch profile, mid-excitation, left; post-excitation, right. The light and angles rendered the ditch very difficult to photograph satisfactorily.**

The ditch was located at between 14.5-19.5m from the north end of the trench, its darker siltier fill very clear against the yellowish colours of the varied till deposits to the north and south (fig. 7 and figs 14 and 15: full east-facing section and overall plan). The maximum width of the ditch just below ploughsoil was at least 4.5m, but the sides had been disturbed by the insertion of two parallel nineteenth-century ceramic field drains 4.5m apart running west-east along the margins of the ditch (see H on overall plan, fig. 15). The ditch's profile had also been disrupted and truncated by repeated ploughing and possibly also by the traffic of heavy machines associated with coal mining as well as agriculture. Excavation had to stop at nearly 1.5m down from ground surface, at which level the ditch was c. 2.5m wide. Until c. 0.9m down from ground surface both the sides were gently sloping at about 45°. The southern side was much less clear and appeared to continue on that gradient. The northern side thereafter became steeper at about 70°. This was likely to be closer to the original lower profile of the ditch.

In section the silty fills of the ditch were a maximum of 0.85m deep below the plough soil, with a 0.15m deep stained interface with 0.1m of redeposited boulder clay evident below (figs 7 and 8). That lowest visible fill of the ditch – the silty, stained sandy clay – may well have been material slumped and settled from the upper sides of the ditch. The silty fills above were organic, mid to dark blackish brown sandy silts (20:80) with c. 5% clay and 20% poorly sorted gravel, pebbles and occasional small cobbles. The gravel, pebble and small cobble content and the compaction varied slightly within the fill, and there were clear tip lines. The ditch fill was gravellier than the u-shaped ploughing infill at the top of the recorded section. There was some charcoal in the fill and an environmental sample was taken from 0.7m down in the ditch, in the fill interpreted as deliberate backfill.

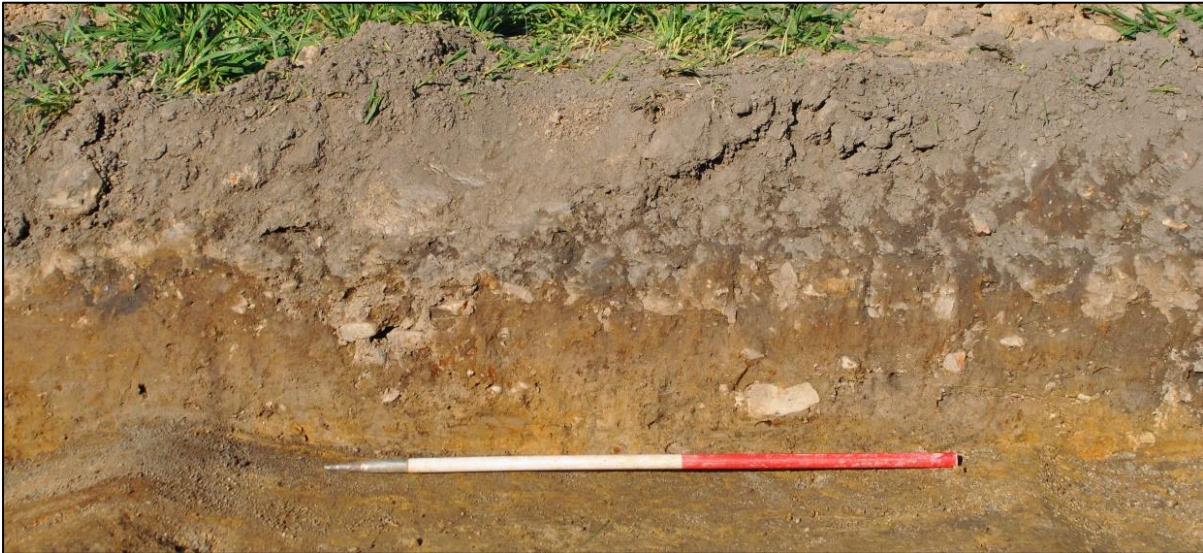
**Fig. 9: west-looking photo of the remains of the north mound**

It is difficult to be certain of construction of the likely north mound from the traces uncovered. The mound foundations may have had a sandy boulder clay base, with a gravelly, silty sand core (figs 9 and 10). Core material survived to a maximum of 0.2m, possibly somewhat displaced from its original location in the mound, and may have been glacial till deposits excavated from the ditch-line. There were many larger pebbles, and the occasional larger cobble up to 0.3m long, in the core material. The occasional flatter cobble provided slight evidence for revetting, or stone kerbs. More convincing evidence, given the hugely degraded character of the mounds, was unlikely to have survived. The clayey, northern edge of the remains was marked by iron panning, presumably caused by iron-rich water trickling down-slope and pooling against less permeable mound material. The grey silty sand laminated with the iron panning might suggest use of turf cheeks in the construction of the mound foundations.

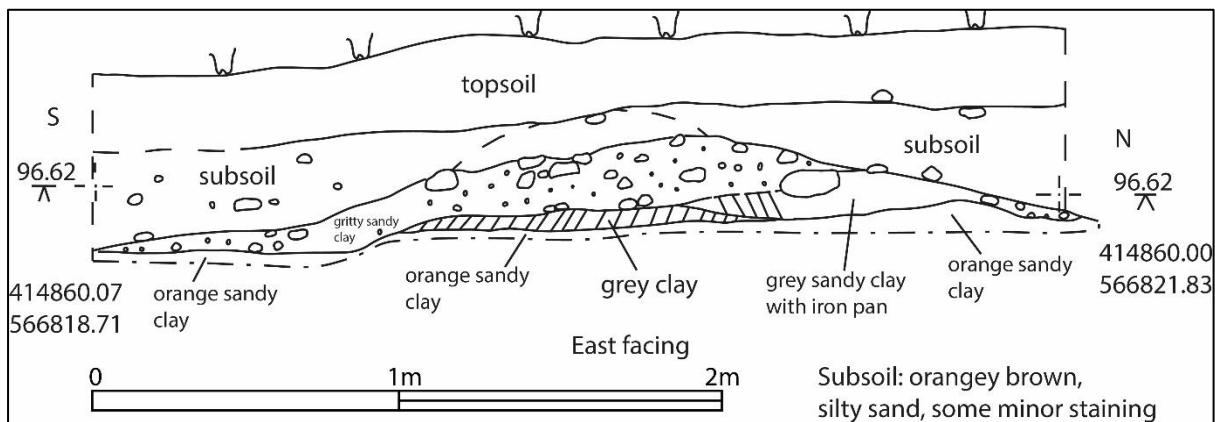
**Fig. 10: east-facing section of the north mound**

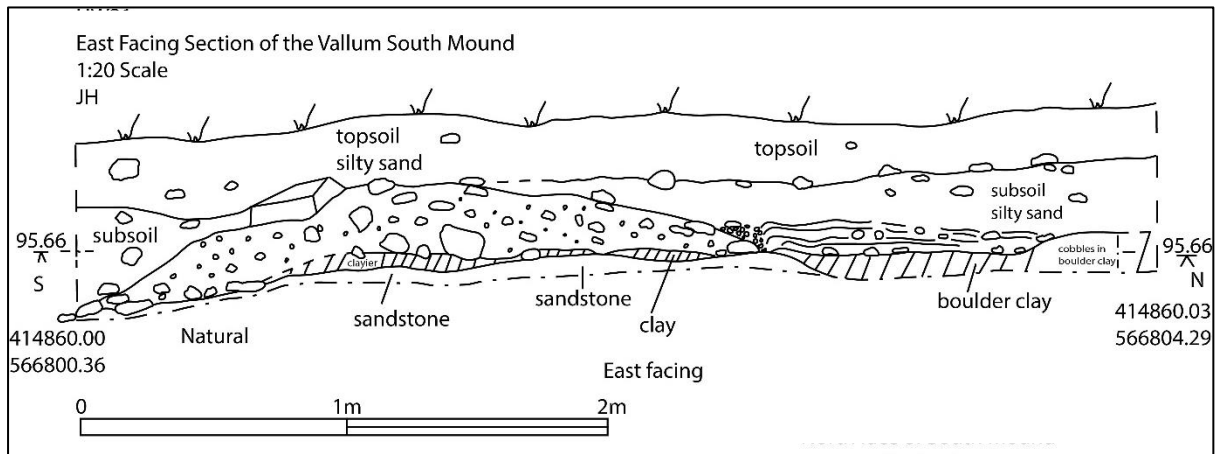
**Fig. 11: east-facing section of the south mound**

As to the north, the south mound archaeology is best described as representing the materials used in construction rather than providing structural detail. Again both the west- and east-facing sections (figs 11 and 12) suggested the foundations may have included redeposited natural sandy clay, with a core of gravelly, cobble-rich silty sand. The southern mound remains were perhaps better preserved and contained a higher proportion of larger sub-angular cobbles up to 0.25m and one angular flatter stone c. 0.4m long that may have been kerbing or revetting. The mound material survived to a height of c. 0.4m and 2.6m in width, although a downslope spread of more stony material may have been mound material, taking the width to more like six metres. A grey clay layer above the sandstone may have been a thin layer of the subsoil onto which the mound was constructed. Even more clearly than at the edge of the northern mound remains, the clayey, northern edge of the south mound was richly laminated with sandy clay, gritty silt deposits and iron panning (fig.12: right-hand side of the photograph). This may represent the remains of turf cheeks altered by post-depositional processes and in particular the effects of iron-rich water.

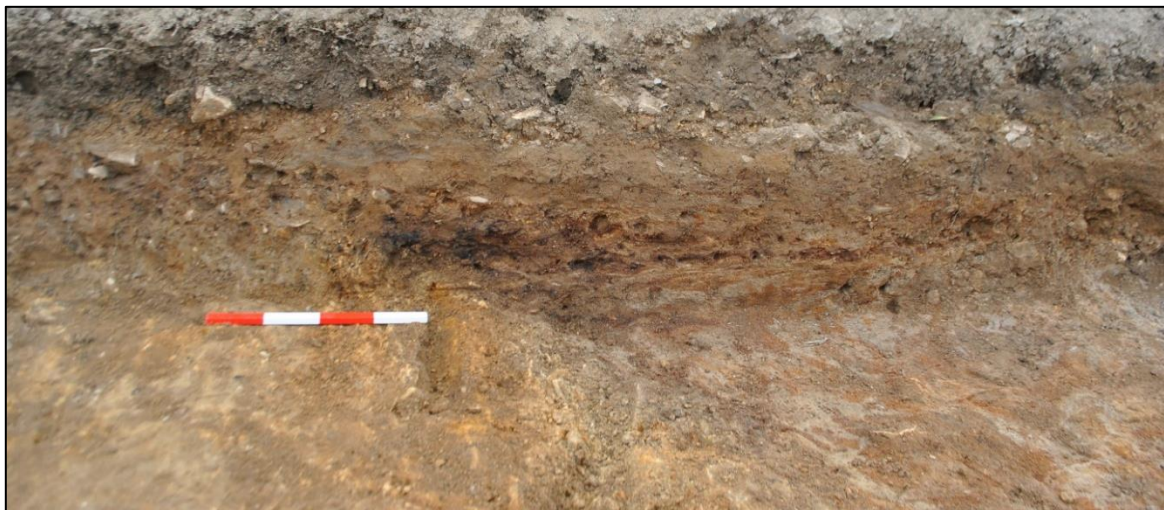
**Fig. 12: west-looking photo of the remains of the northern end of the south mound**

The mounds survived as ghosts of their original surface construction. Excavation caught the effects of the settling and build-up of water and damper soil against the upslope foundations of the mounds (fig.

12), and the altering of the soil around due to the incorporation of material used in the foundations, core and possible turf and stone revetting. The north mound's remnants were located between seven and ten metres from the north end of the trench. The mound had been constructed above gravel and pebble-rich sandy clay, with a band of grey clay possibly representing traces of a buried land surface. The surviving tail of the mound was only around five metres north of the spread northern edge of the Vallum ditch, suggesting that the north mound was relatively close to the ditch (see discussion below).

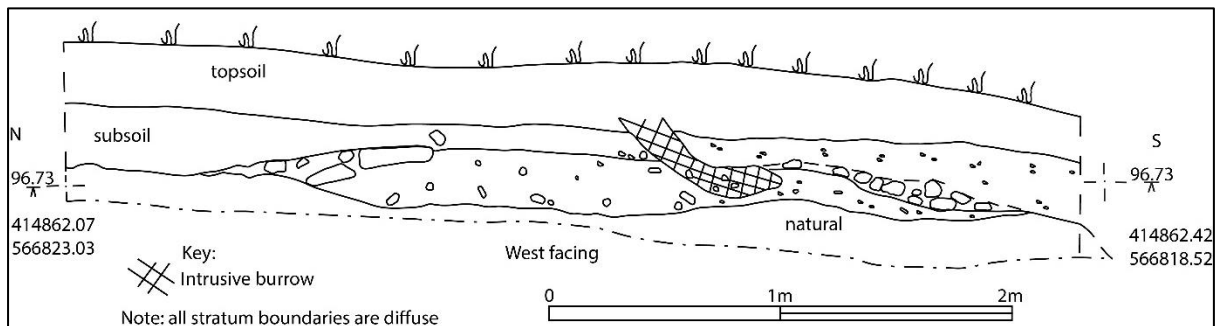
**Fig 13: west facing section through the north mound**

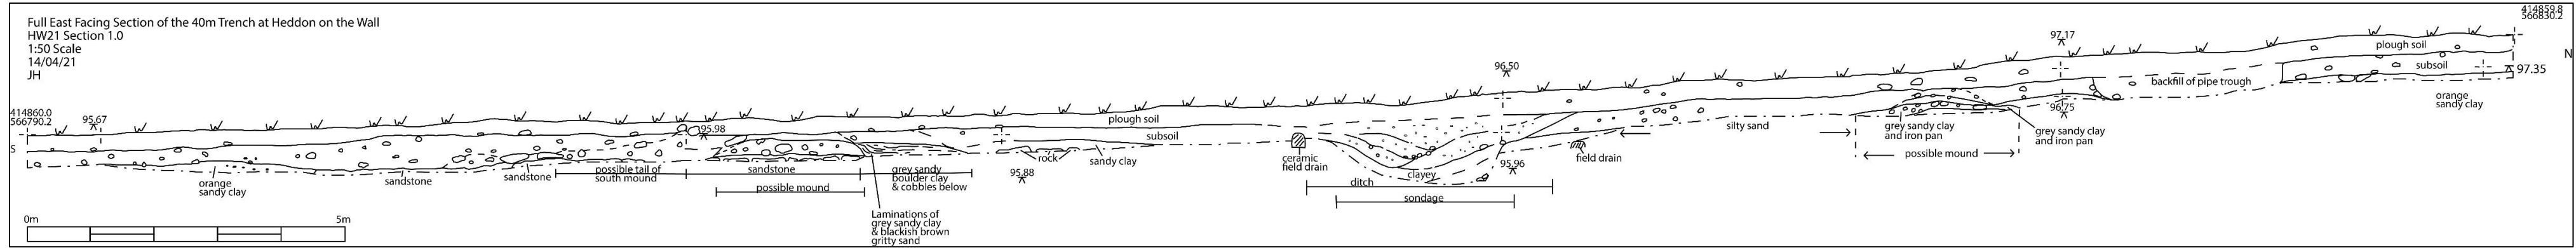
Fig 14: east-facing section of entire trench, post-excitation

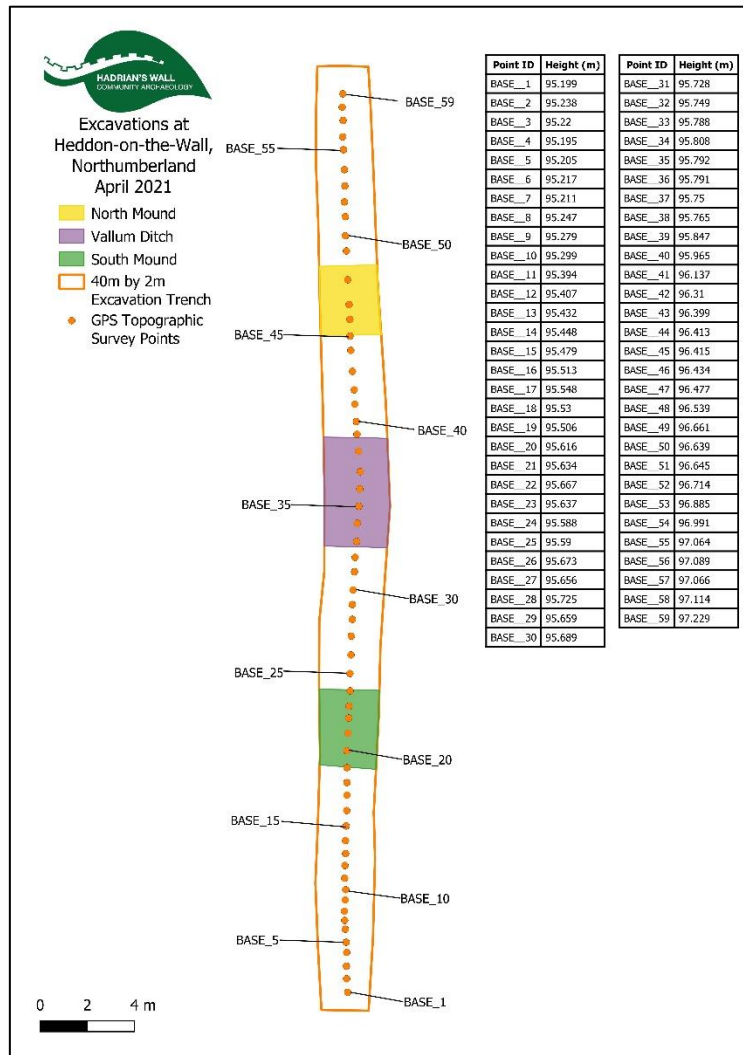
**Fig. 16: trench base elevations with features**

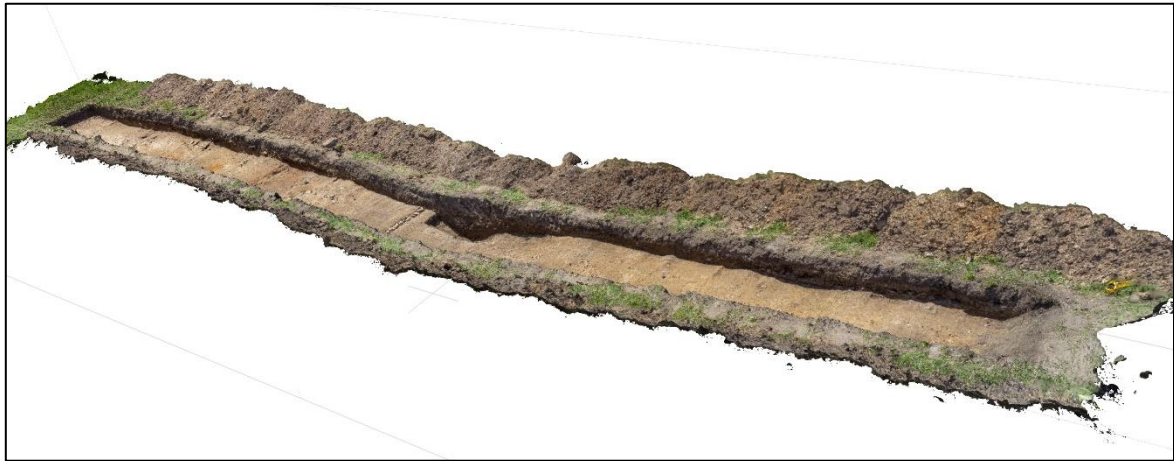
**Fig. 18** photogrammetry of the trench post-excitation, looking south-west
