PortCarlisle, Hadrian's Wall, April 2021: PC21, excavations across the Wall

Hadrian's Wall Community Archaeology Project (WallCAP)

Jane Harrison and Kathryn Murphy

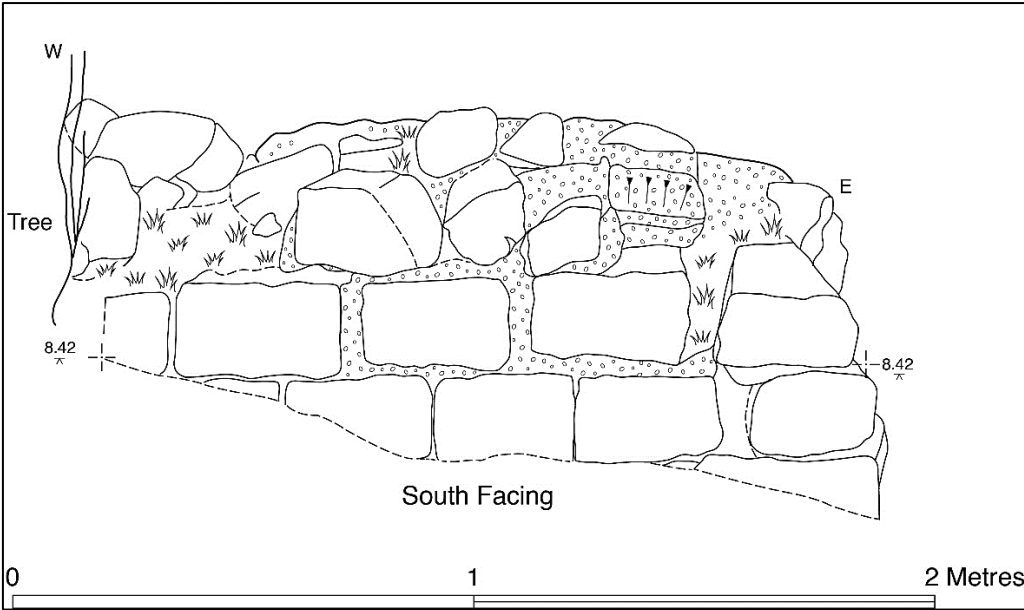
Fig. 4a: PC21 Elevation 1.0

The curtain remains were drawn (figs 4a and 4b) and photogrammetry done (final images pending). A visual and measured survey of the mostly very thick hedgerow was completed between the gateway and the field corner where Trench 1 was located. In only two places was the hedge growth sparse: in the vicinity of Trench 2 (see below) and where the building was recorded on the 1970 OS map, the location of Trench 1.

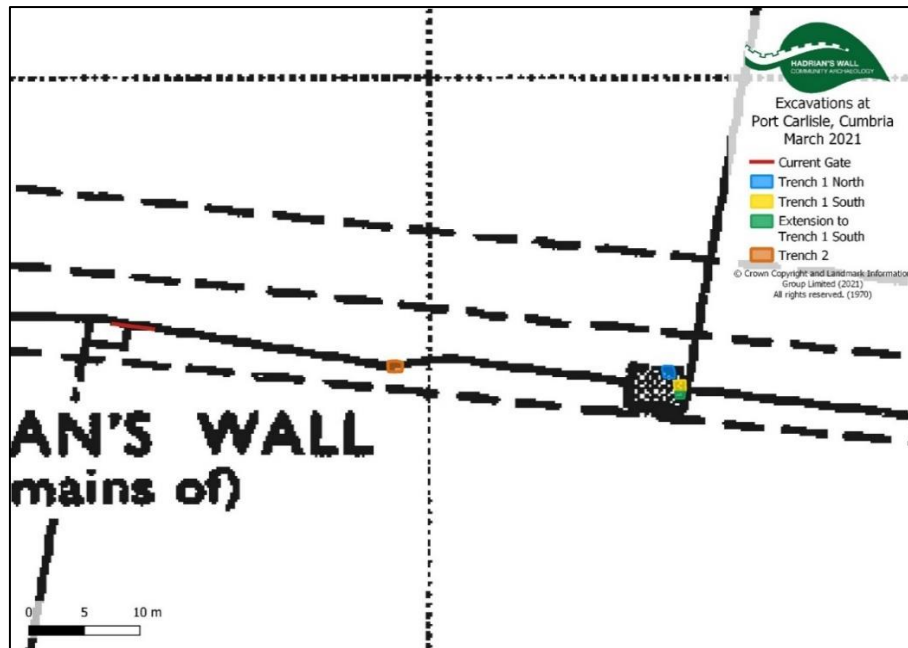
Fig. 8: Trench and gate locations on 1970 Ordnance Survey mapping, with the building shown beneath Trench 1

Trench 1, was located to investigate the line of the Wall in the location of an agricultural building shown on the 1970 Ordnance Survey map (fig. 8). The trench was divided between north and south of the likely wall-line with the northern quadrant off-set from the southern quadrant to create a complete section through the area without removing the wooden fence on top of the bank. The northern and southern parts of Trench 1 were significantly different, with much more disturbance apparent in the layers forming the southern slope of the bank, partly as a result of the construction and demolition of the building. The northern slope had been more affected by flood deposits and the effects of a rising and falling water table. However, the layers could still be correlated from north to south, and together demonstrated that all Wall facing stones had been removed in this area, and that wall core had been re-purposed both to revett the hedge bank and to make a foundation surface for the building. Further disturbance had been caused by the digging of a rubble drain south of the Wall and by the digging out and redeposition of flood deposits on the northern side. The southern extension was made to confirm the character of the rubble drain and the absence of any foundation stones.

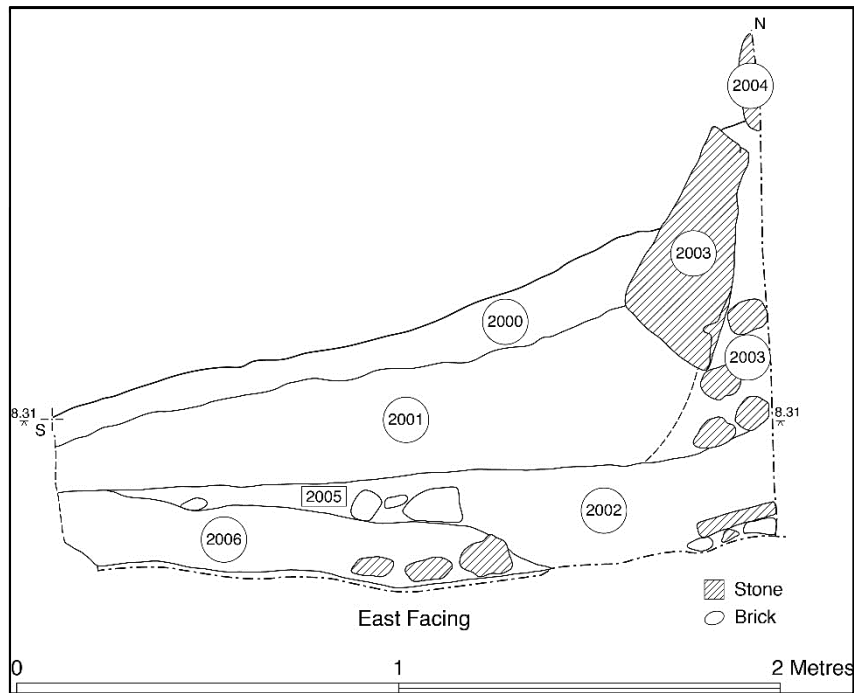
Fig. 14: Trench 2 section drawing, east facing

The earliest layer (2006) uncovered in Trench 2 was seen in the southern half of the trench, the northern half having been cut away by the west-east ditch/rubble drain [2005] also seen in Trench 1. Layer (2006) was a gritty, dark greyish brown, sandy silt with frequent sub-rounded pebbles but also a considerable number of larger sandstone cobbles and sandstone shatter (at least 40%). This appeared to be a subsoil containing some redeposited and spread wall core material. The layer would have been created over time as facing stones were robbed, the field bank was reshaped, and repeated ditches were cut in attempts to

A west-east ditch [2005] had been cut through this layer (2006). This ditch – probably a French or rubble drain – is visible today as a very slight dip south of the field bank and running along the entire length of the field boundary. Although the ditch line was heavily truncated and probably disturbed by attempts to run another drain from it northwards, it had been at least 0.5m wide. The ditch was completely back-filled and covered to create the foundations for a probably relatively small, earlier than mid-Victorian agricultural structure. The upper fill of the ditch (2002) was subsequently mixed with demolition debris from the removal of that building: it was impossible to discern the boundary between remaining ditch fill/rubble fill and levelled demolition debris. The combined, reworked layer comprised a friable, humic, dark greyish black, sandy silt with small pebbles and in the lower layer more than 50% small-medium sorted cobbles. It was found across the trench, thinning to the south and deepening to 0.25m in the centre of the ditch to the north. Eight sherds of nineteenth-century bottle glass, a bone knife handle and many fragments of hand-made bricks were collected from (2002). The upper layer was composed of levelled dumps of material– in particular, brick fragments – and finds clustered in different areas of the trench.

After the removal of the structure, the field bank was rebuilt using many cobbles and some larger sandstone blocks, the majority of which latter stones could have originated as wall core, all held together by clayey silt soil (2003). Finally, a number of curtain facing stones, which may already have been re-used in the building, were lined up along the bank to complete the restructuring [2004]. Four of these were visible, three at the top of the trench and one to their immediate west. The three stones in Trench 2 were similar in size to those recorded in the *in-situ* courses to the west by the field gate, averaging at around 0.3m long by 0.18m high. However, the stones were either not re-set in the bank with the front faces outwards or they had twisted in settling and/or been disturbed. Only the stone to the immediate west and most eastern of the stones in the trench might be facing approximately the right way.

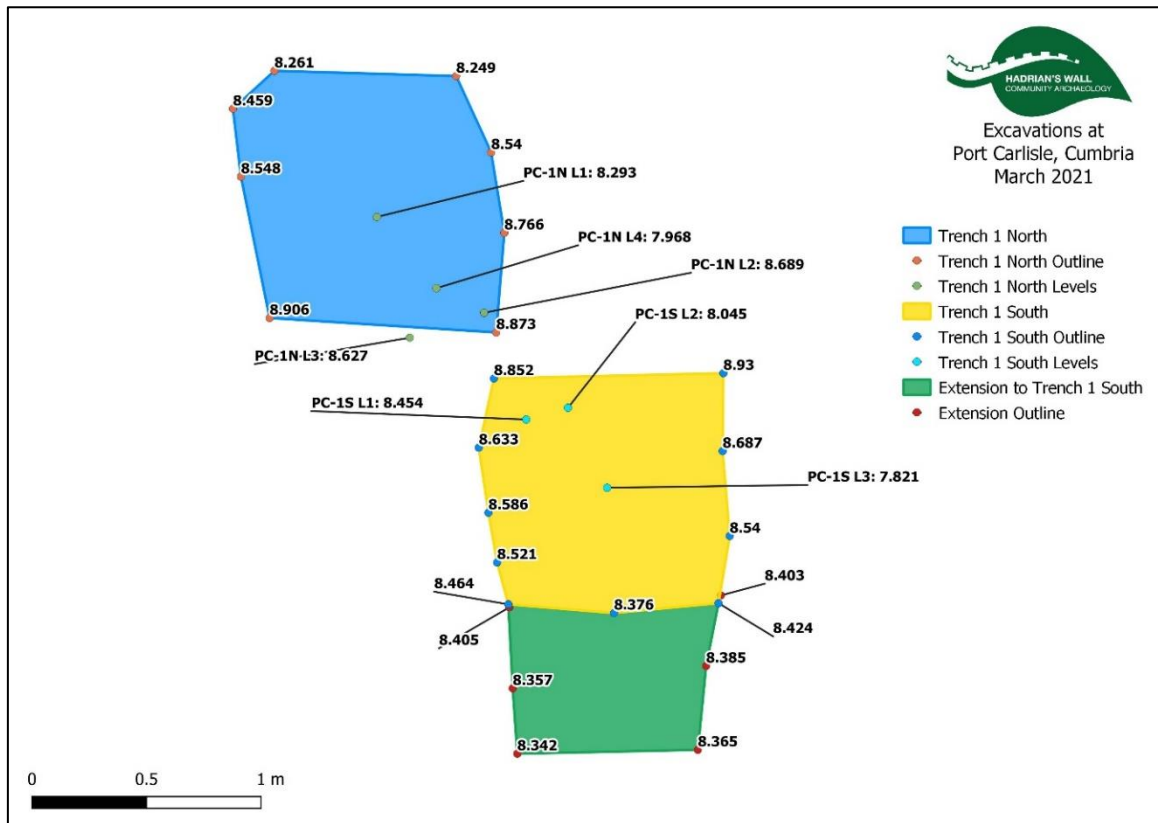
Fig. 17: Trench 1 outline with levels in m

PC21: Trench 1			
Context No. <i>Type</i>	Physical relationships <i>Levels mOD</i>	Description <i>Interpretation</i>	Drawings: on reverse of all context sheets
1005 layer: trench north	Below (1003); over (1004) <i>Top: c 8.29mOD</i> <i>Bottom: c 8.00mOD</i>	Friable-compact mid greyish brown silty sand (40:60); small-medium s0% sub-rounded cobbles, pebbles and grit c 20%; Layer 0.2-0.25m across trench above natural; boundaries clear. Some bioturbation. <i>Interface between field bank and natural glacial till/fluvial deposits.</i>	
1006 layer: trench south	Below (1001) LOE <i>Top: c 8.40m OD</i> <i>Bottom: c 8.34m OD</i>	Friable, gritty mid orangey brown humic sandy silt (30:70); sub-angular, angular cobbles of yellow and red sandstone, 50%, majority 0.1 x 0.1m, occasional larger stone 0.2 x 0.2 x 0.4m ; small pebbles and grit 10%; across 0.6m x 1m extension south, dug for c 0.1m until ditch line and lack of facing stones discovered. <i>Small extension of Trench 1 southwards on south side. 1m W-E by 0.6m N-S to confirm no Wall foundations and to trace line of rubble drain. Rubble drain northern edge located and no facing stones or likely in-situ core material found.</i>

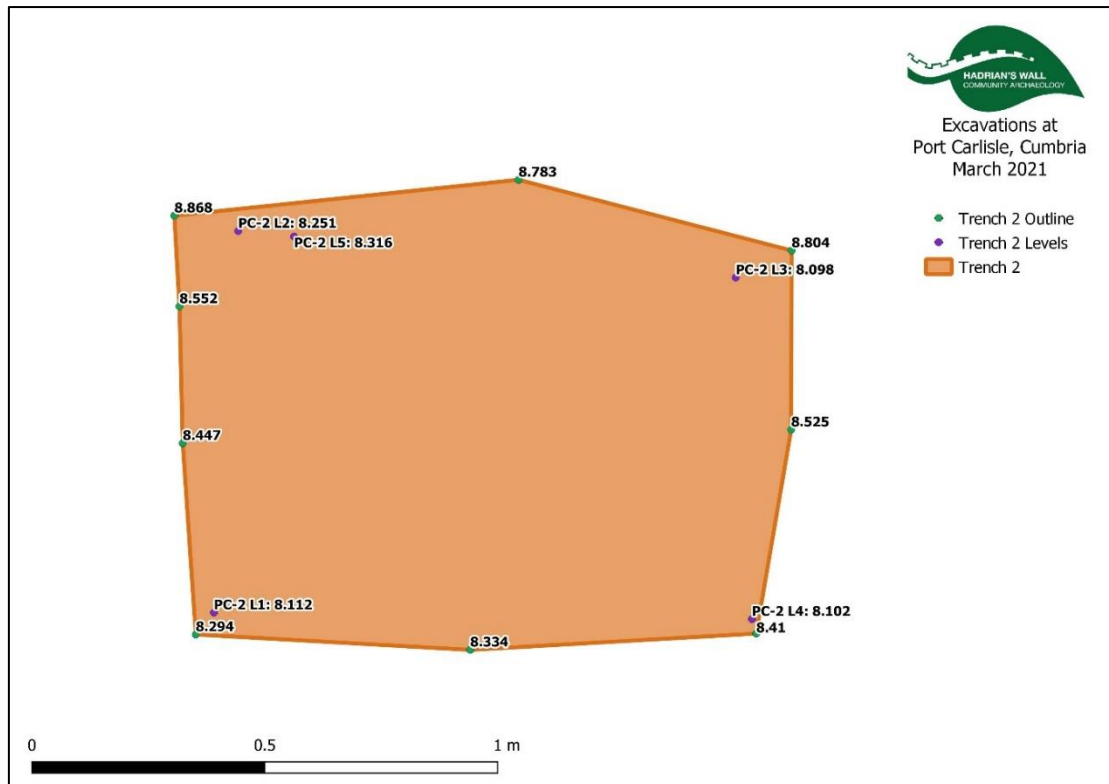
Fig. 18: Trench 2 outline with levels in m

2005 cut	Cuts (2006); filled by (2002) <i>Top: c 8.10m in S, bottom in ditch c 7.85mOD</i>	Truncated ditch with spread gently sloping west side visible in east-facing section, with 45° slope after break of slope to lowest level of ditch excavated. Bottom not quite reached (max. 0.25m deep) and only short portion of northern return slope caught in section. 1.7m wide as revealed across the trench, but possibly disturbed by re-cuts or ditches running to the north. <i>Disturbed length of ditch/drain visible elsewhere as a slight dip running W-E to south of bank. Also seen in Trench 1. The ditch preceded the building.</i>	Sec: 2.0
2006 layer	Below (2002), cut by [2005] (2005); LOE <i>Top: c 8.0-8.1 mOD Bottom: 8.0mOD, LOE</i>	Friable to compact dark greyish brown, gritty, sandy silt (30:70); grit; frequent sub-rounded pebbles and large sandstone cobbles c 30% of context. <i>Subsoil with some likely deposited and spread wall core created over time as facing stones robbed and work done to shape field bank and improve drainage.</i>	Sec: 2.1
